## REPORT

### Park Meadows Brick Wall Report

Park Meadows Brick Wall Study  
ANA Job No. 20-235  
September 3, 2021

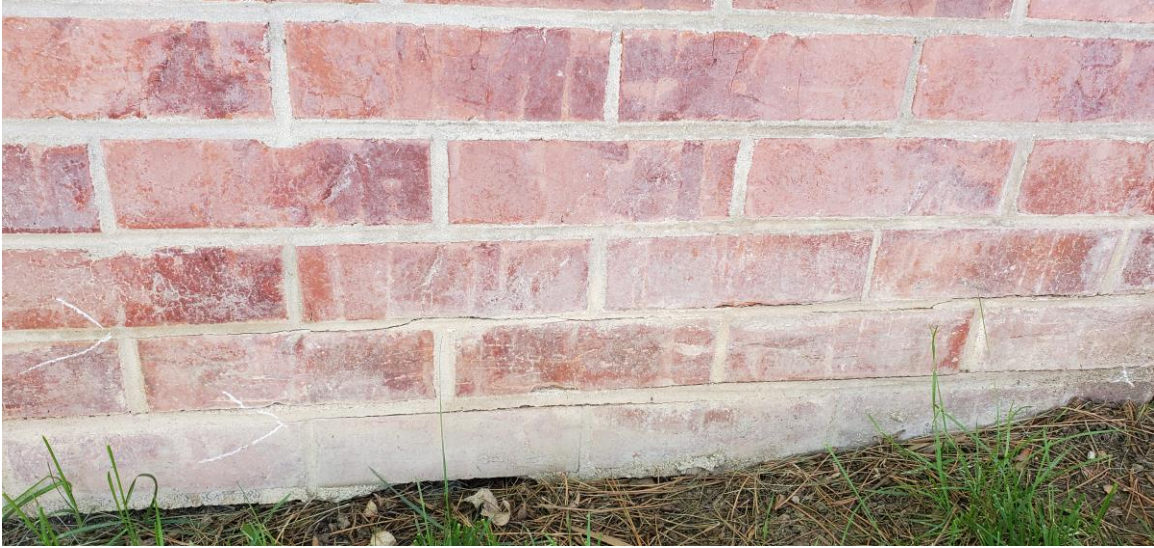
The type of distress referred to as panel sagging generally includes separation of the bottom few courses of brick downward from the remainder of a panel. The most common sagging behavior involves cracks or openings that are relatively wide at the middle and narrow at each end of a panel. However, sagging has also been observed near ends of panels and at steps along the bottom edge. ANA divided panel sagging into three different levels of distress: crack panel sagging, sag panel sagging, and collapse panel sagging (in order from minor to severe distress). Examples of each level of distress are shown in Figure 20 through Figure 22.

There are several likely contributing causes of panel sagging distress. One contributing factor is related to how loads travel through the panels. In structures, loads travel primarily along the stiffest available path. In the case of the wall panels, this path is often in an arch shape between the foundation supports. However, the original design envisioned that the panel would behave as a beam that spans over the gap between foundation supports. The arching action behavior places much of the top and ends of the panels in compression (which is beneficial in masonry), but the bottom center portion of the panels may be left to "hang" from this arch. This behavior is demonstrated schematically in Figure 23. Since only minimal smooth wire is oriented vertically to help resist this hanging motion, the bottom portion of the panel is prone to breaking free and sagging downward under its own weight.

A second contributing factor to panel sagging is the manner in which the bottom course "bond beam" is constructed. Since the width of the bottom course of brick is only approximately 2 5/8" thick, there is not room for a conventional bond beam unit with horizontal reinforcing that is grouted in place. Therefore, the construction consisted of reinforcing that was placed into a narrow slot with some mortar. Not only is the strength and bond of this mortared reinforcing substantially less than grouted reinforcing, but the mortar also provides very poor cover or corrosion protection for the reinforcing bars. For these reasons and others, installation of reinforcement with mortar is not permitted by the Building Code in these circumstances. One of the consequences of poor cover of the "bond beam" reinforcement is that many reinforcing bars have begun to corrode. Corrosion of steel involves expansion that is also contributing to popping the bottom courses of panels free from the supporting panel above.

Finally, another significant contributor to panel sagging is likely the very flexible nature of the panels. The body of the brick walls is only approximately 2 13/16 inches thick, significantly less than a standard brick thickness of 3 5/8". The flexibility of the panels is apparent from the vibration felt whenever a panel is knocked on with a fist or foot. This flexibility also makes the panels susceptible to damage from minor impacts such as lawn mowers or shovels striking along the bottom edge.

Figure 20. Example of "Crack Panel Sagging" distress, the minor category of panel sagging.

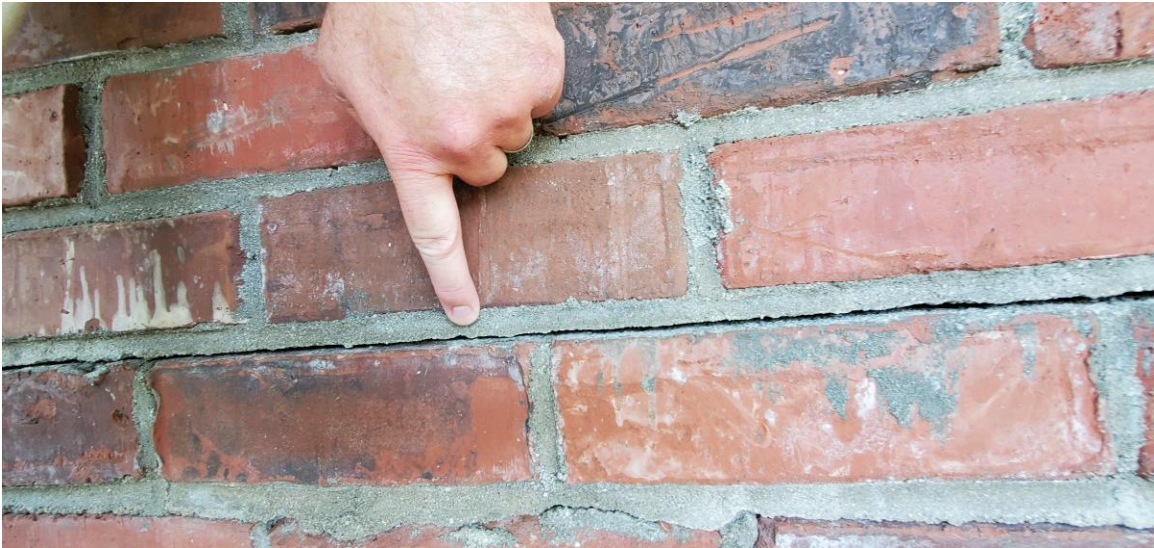
Figure 21. Example of "Sag Panel Sagging" distress, the moderate category of panel sagging.

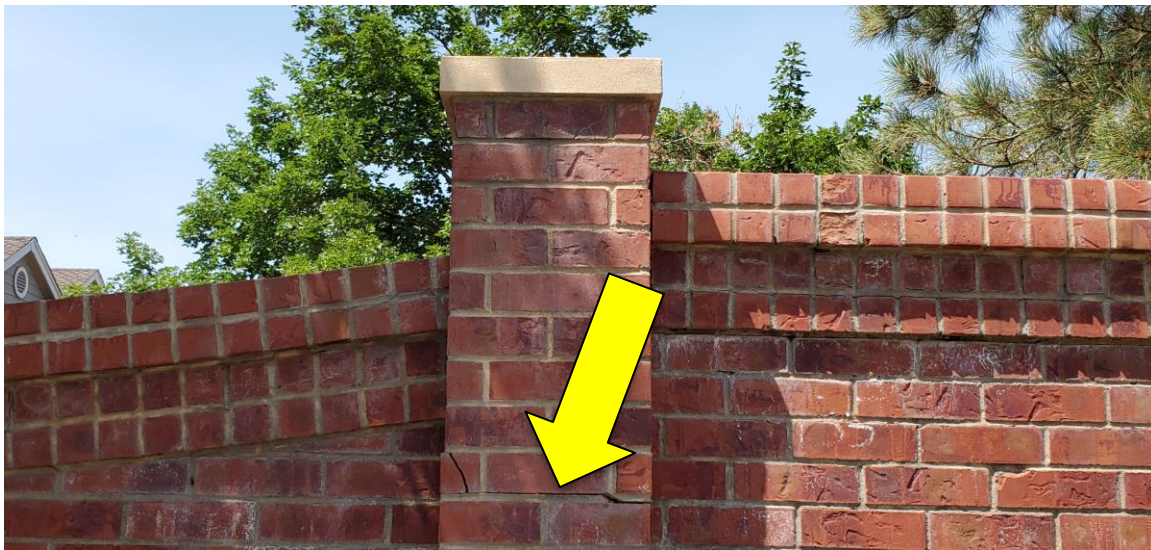
There are several common construction issues related to expansion joint installation at the subject walls. The most common issue is that the open joint required between the cap and column at the expansion joint location is often filled with mortar or is constructed without any gap. Where this condition is present, the brick panels expand, and the body of the panels is permitted to slide into the slotted expansion joint within the column. However, the cap pushes on the column and has no room to expand. Since this pushing is generally happening from both sides, the caps tend to crack horizontally and buckle upward, sometimes bringing the top of the column along with them, as shown schematically in Figure 25. Examples of the column pop-up behavior are shown in Figure 26 and Figure 27.

Figure 26. Example of Column Pop-Up distress, showing a horizontal crack in the column beneath the cap level, indicated with arrow.

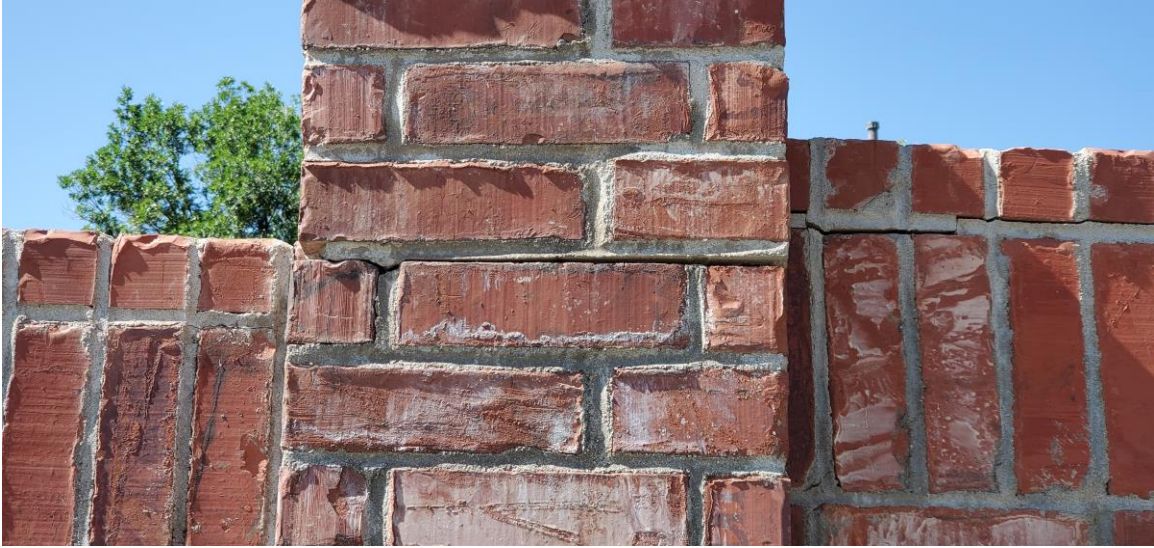
Figure 27. Example of Column Pop-Up distress with the cap buckling slightly higher on the right side.

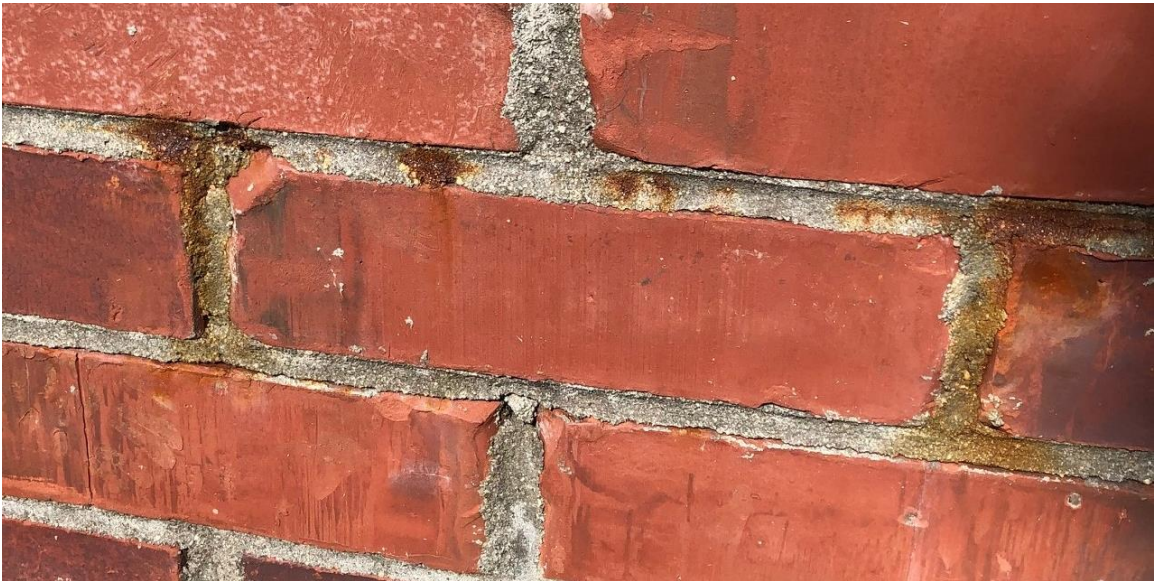
There is steel reinforcing present in both the bed (horizontal) mortar joints of the wall panels and in the bond beams at the base of the panels. Both types of reinforcing are embedded in mortar and have little cover (corrosion protection) due to the very thin nature of the panels. This poor protection, along with salt spray from adjacent roadways and moisture issues contribute to the observed corrosion of reinforcing. An example of bed joint reinforcing corrosion is shown in Figure 28, and an example of bond beam reinforcement corrosion is shown in Figure 29.

Figure 28. An example of corroding bed joint reinforcing.

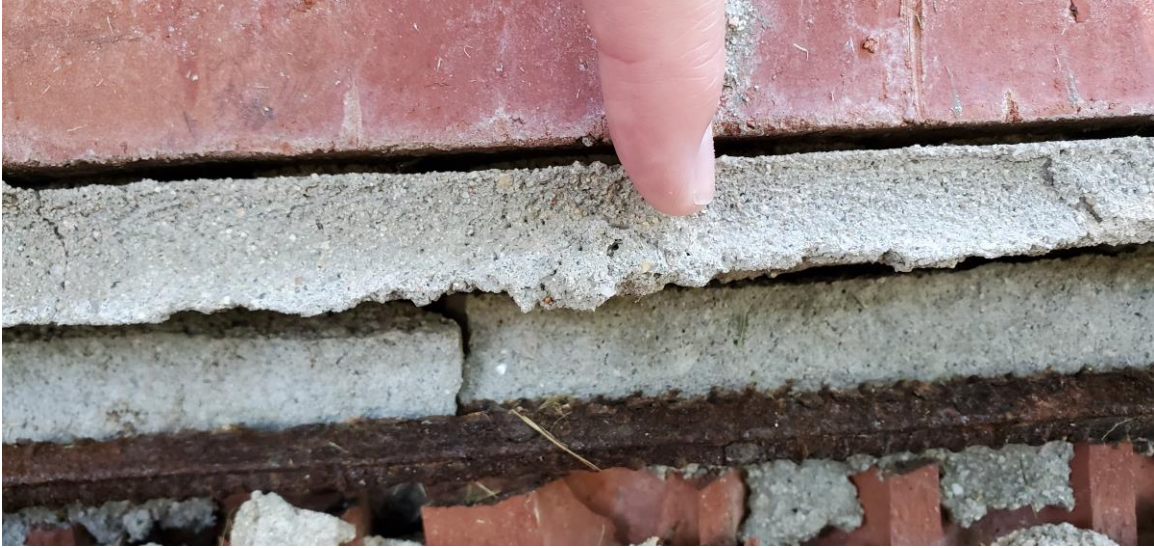
Figure 29. Example of corroded reinforcing bar in bond beam at the bottom of a panel.

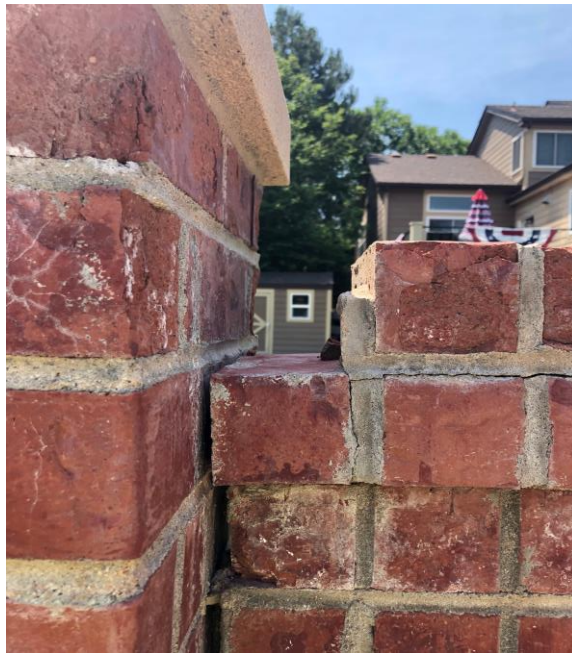
At some locations, brick units were observed to be missing from the wall panels. The loose units had sometimes been set on top of the panels or had fallen to the ground near the panel. In many cases, the missing units were not visible near the wall panel. Generally, missing units were concentrated at wall caps and tended to be associated with horizontal cracking and solid cap expansion joint conditions that caused the cap to buckle. An example of a missing brick unit is shown in Figure 30. Bricks that were significantly deteriorated, usually with more than about 20% of material loss were also marked as missing since these units would require replacement as part of a repair scheme.

Figure 30. Example of a missing brick unit at a wall cap.

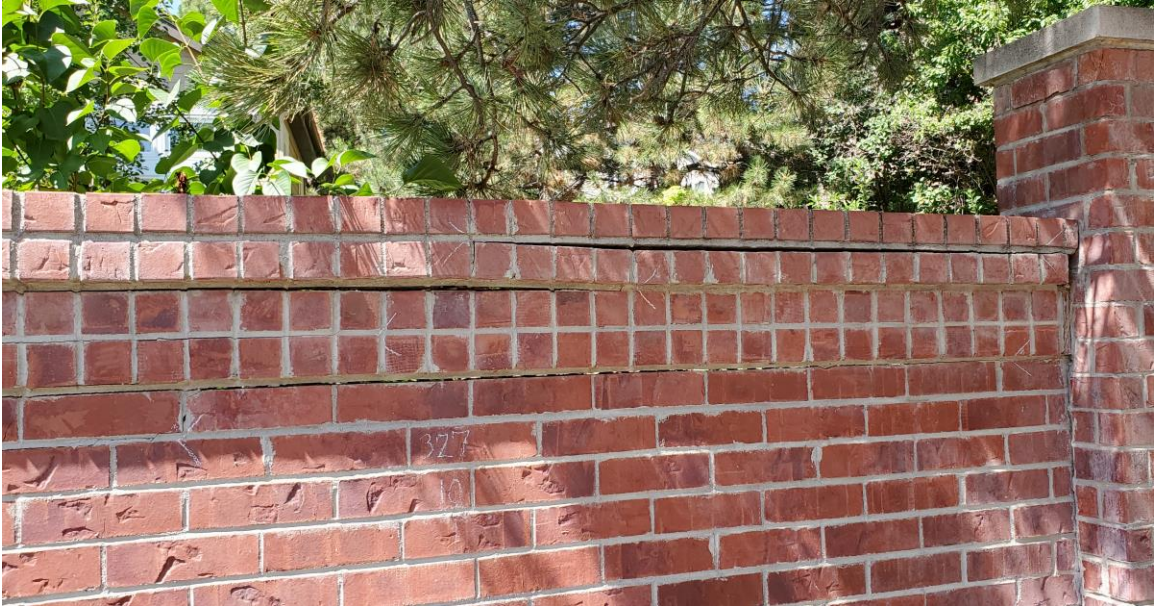
As discussed in the section above related to Column Pop-Up, caps with solid expansion joints tended to cause buckling of the caps as the brick expands. This behavior can lead to extensive horizontal cracking, generally concentrated in or near the caps. This cracking is sometimes exacerbated by a step-down in the cap at panels where the ground slopes along the length of the wall, as shown schematically in Figure 31. An example of cracking in a panel is shown in Figure 32.

Figure 32. An example of horizontal cracking in and near a cap that is buckling due to expansion that is not accommodated with an open joint at the level of the cap.

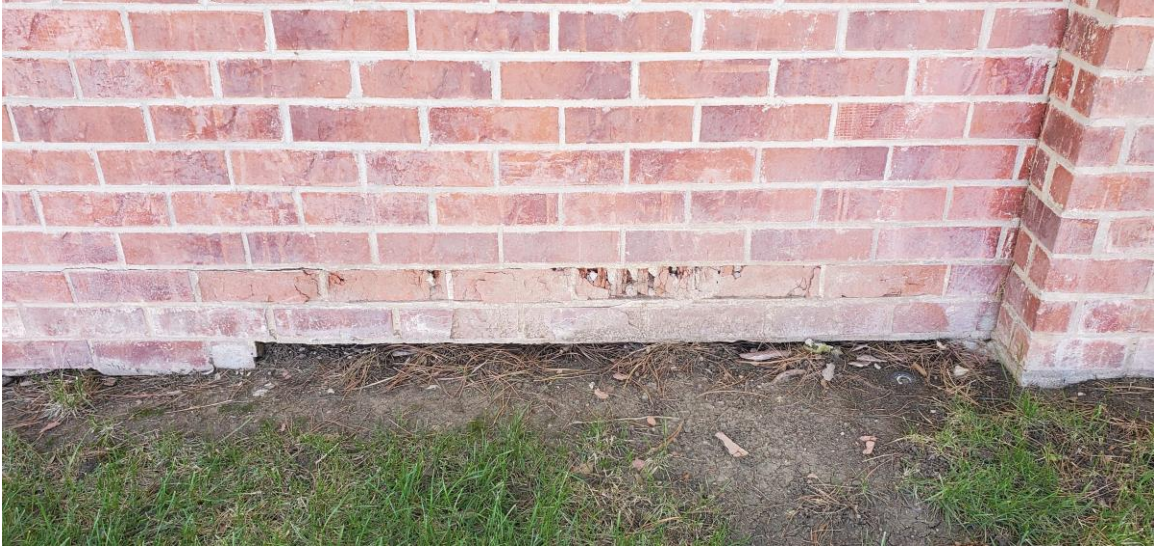
Spalling or surface loss of brick at the subject panels is related to several contributing factors. One factor is that brick was used on the project that does not meet modern ASTM material standards for absorption and saturation coefficient. These properties are improved when brick is properly fired to a high temperature. It is cheaper to manufacture brick that are not properly fired since it requires less fuel for the firing kilns.

Figure 33. An example of panel spalling distress, likely related to retained soil on the opposite side of the wall.

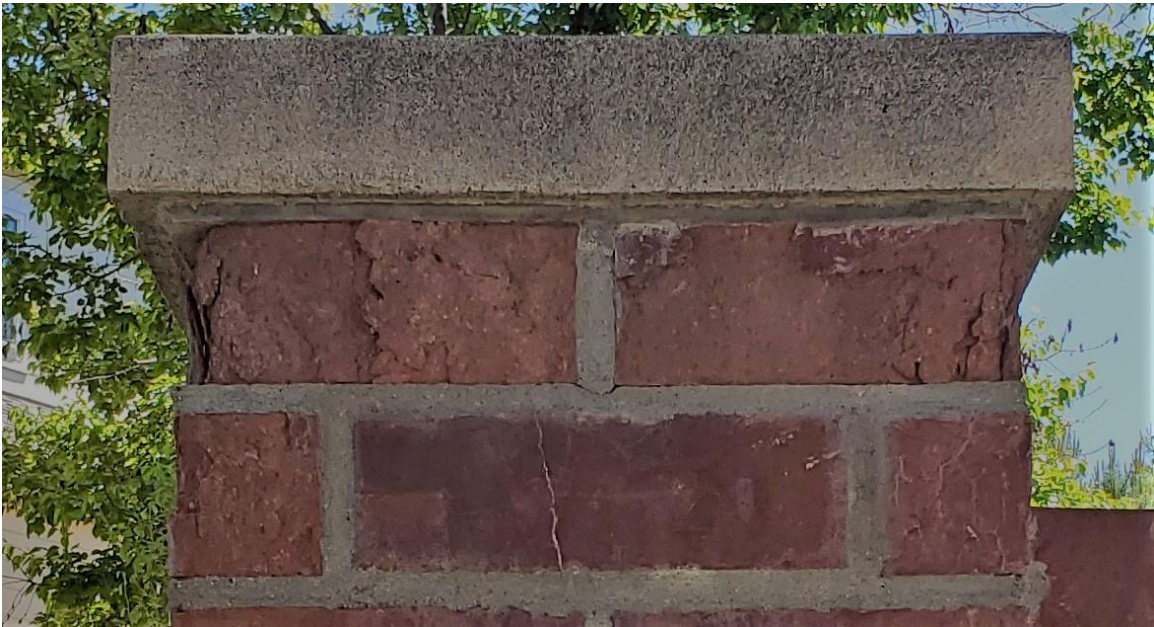
Figure 34. An example of brick spalling beneath a column cap.

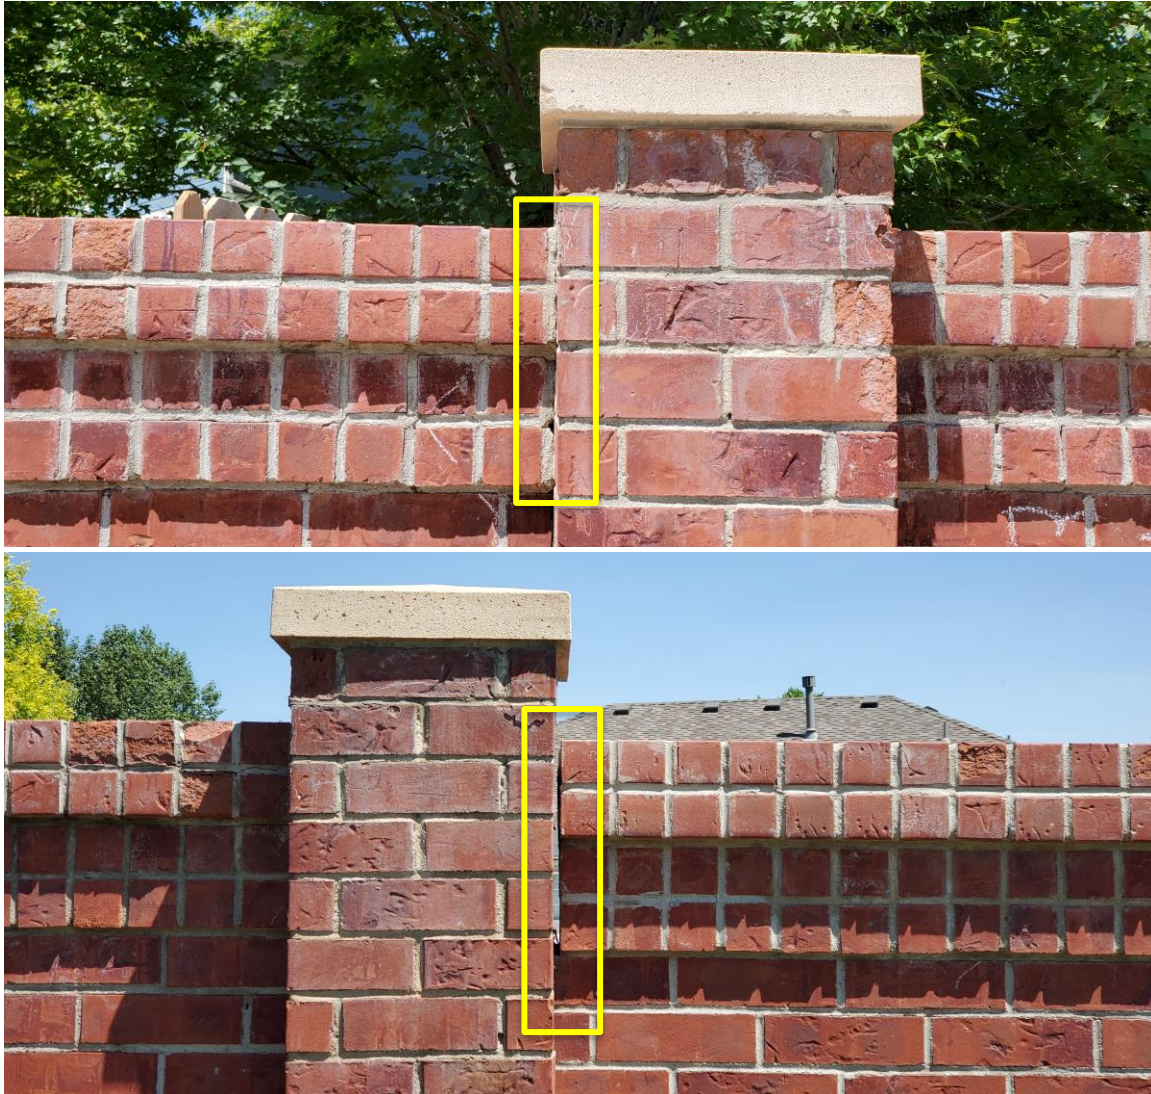
Figure 35 The top picture is a cap solid expansion joint, and the bottom is what a properly constructed cap expansion joint looks like. Note the light visible through the open joint.

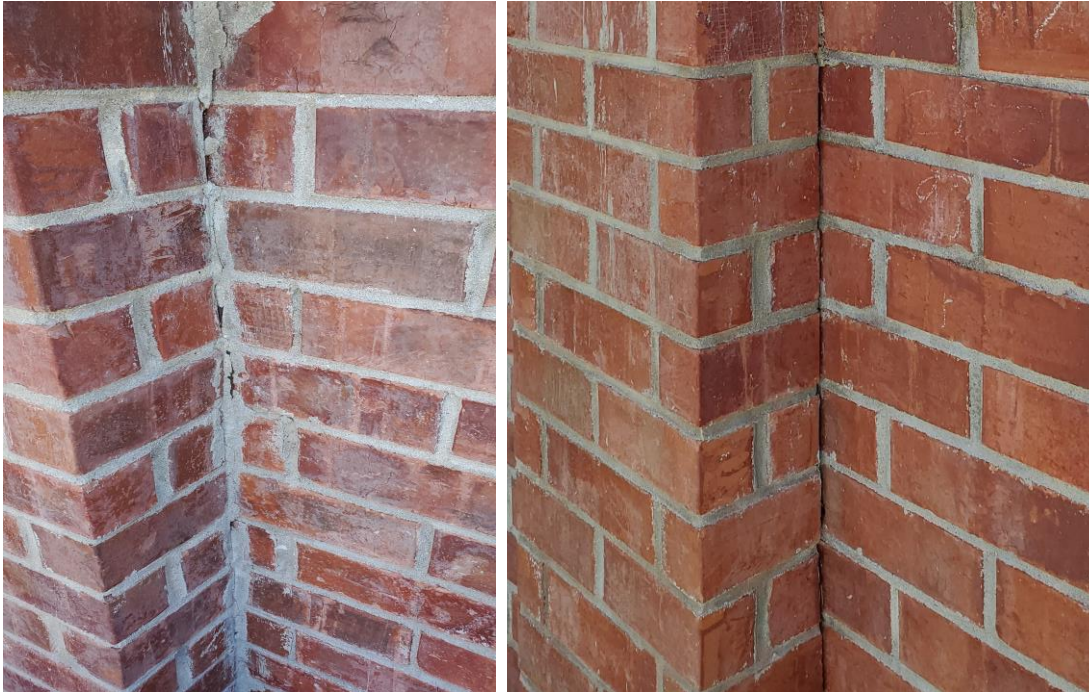
Figure 36 On the left is a panel solid expansion joint, and the photograph on the right shows a properly constructed panel expansion joint.

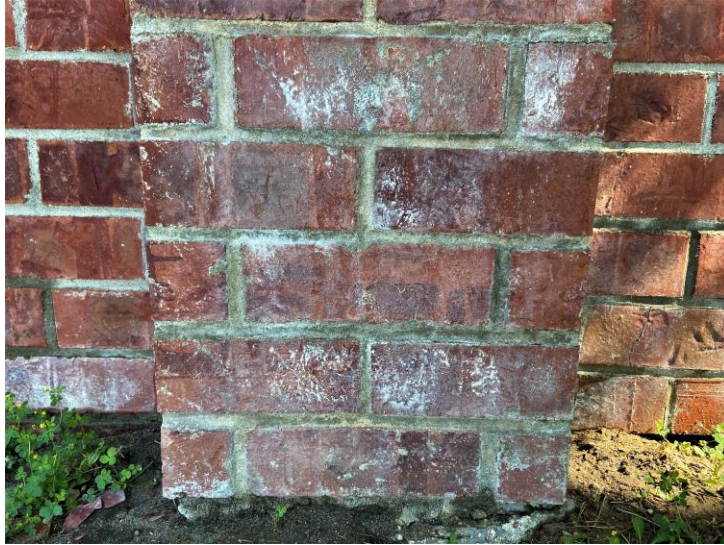
Figure 37. An example of efflorescence at a column.

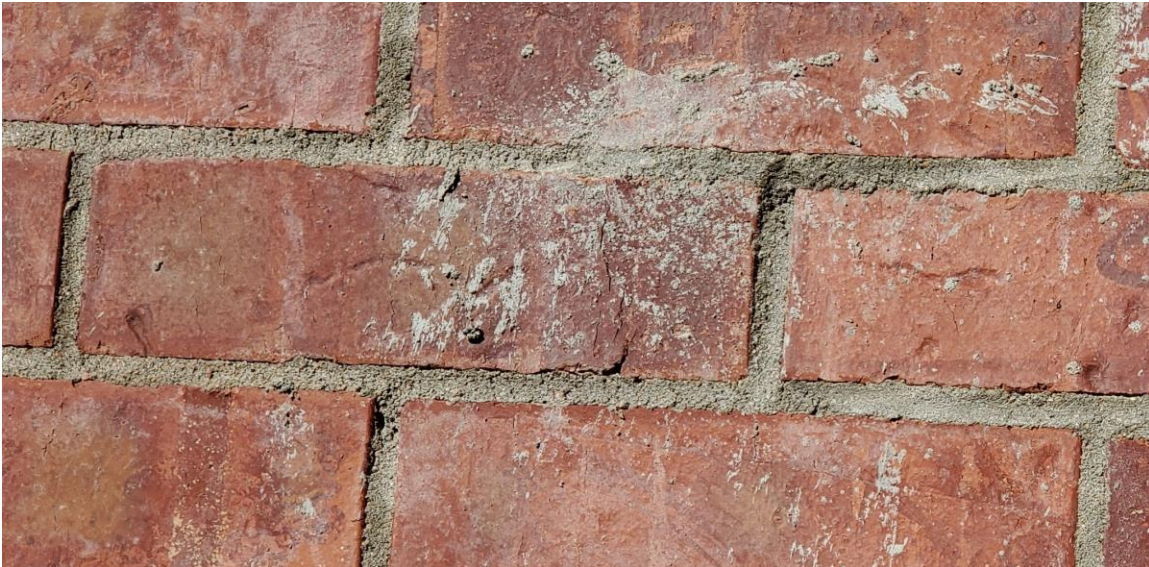
Figure 38. An example of mortar staining that was marked by ANA as an area for cleaning.

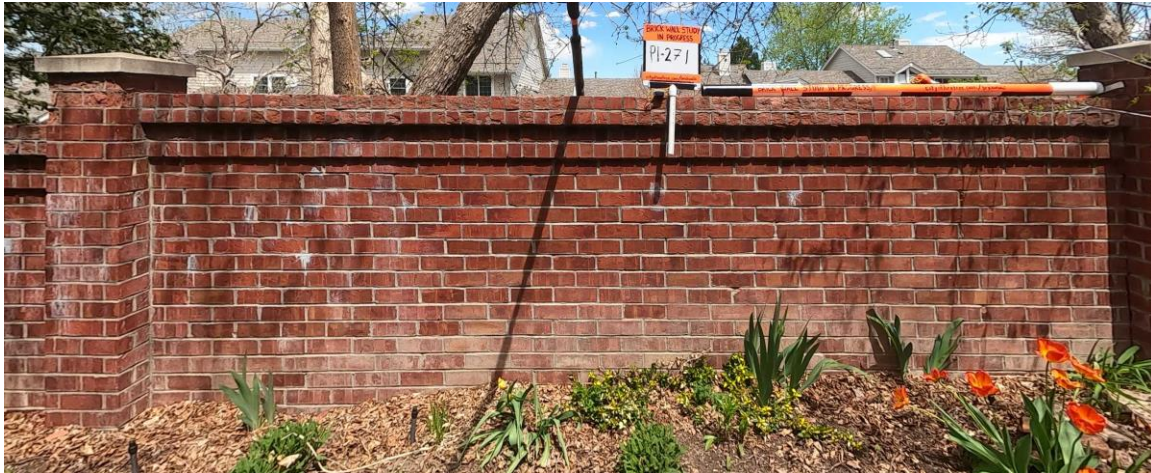
Figure 39. An example of a panel with significant retained soil viewed from the yard side. Approximately 15 courses of brick are visible in the panel above grade.

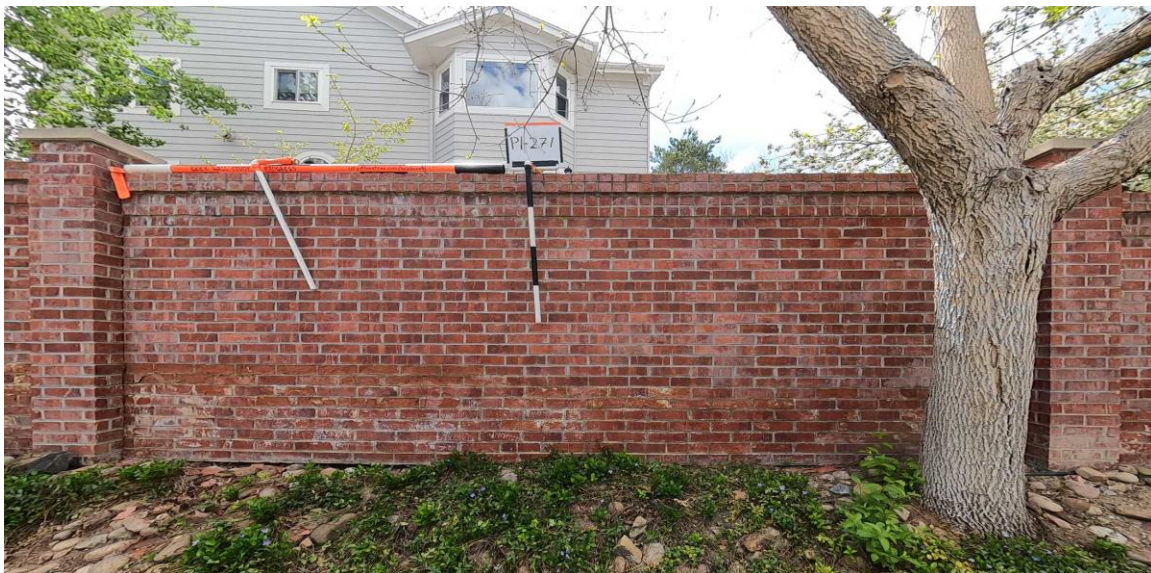
Figure 40. An example of a panel with significant retained soil viewed from the street side. Approximately 23 courses of brick are visible in the panel above grade (i.e. the soil on the back side is approximately 8 courses or 2 feet higher than the front).

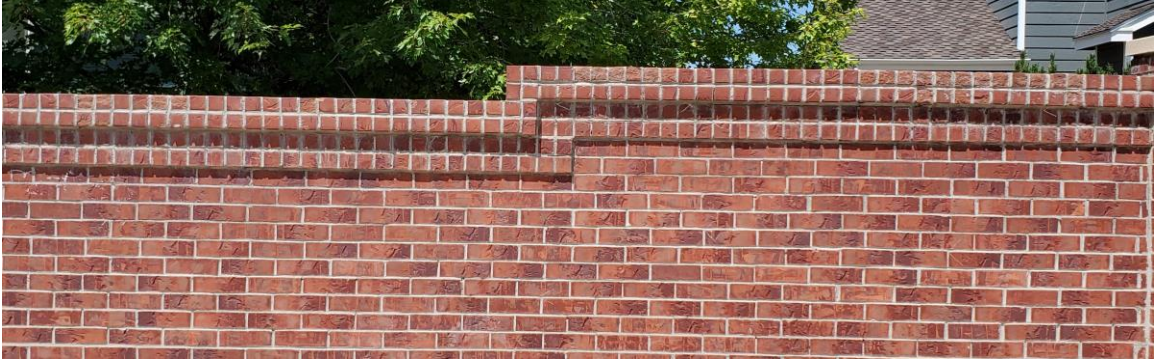
Figure 41. An example of a cap with less than 30% spalled units.

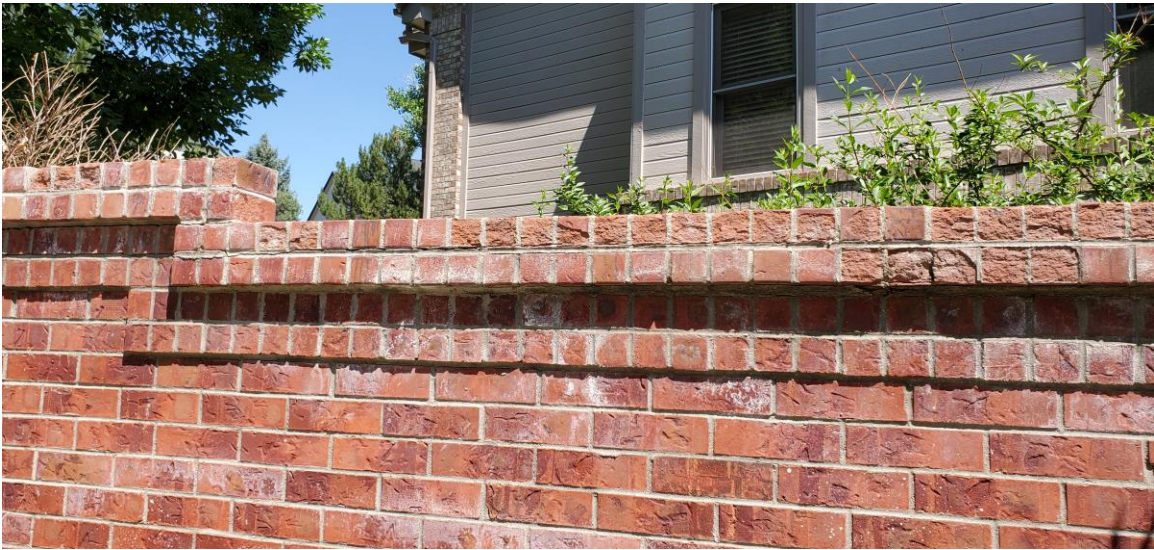
Figure 42. An example of a cap with 40% to 70% spalled units.

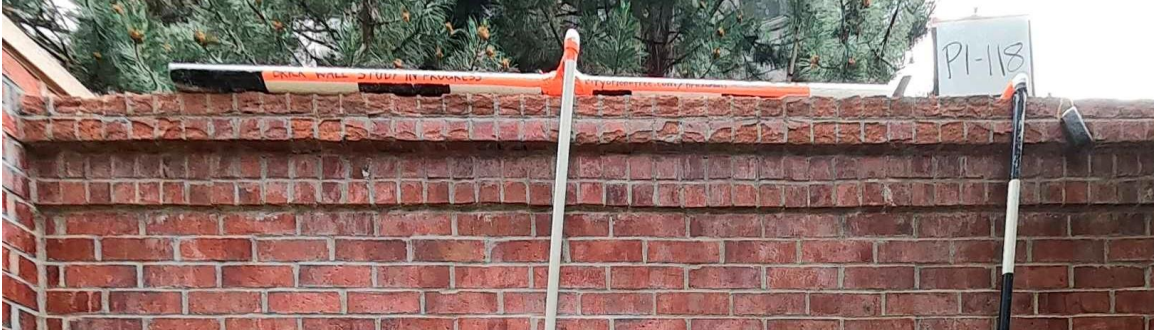
Figure 43. An example of a cap with 80% to 100% spalled units.
