## PHASE I ENVIRONMENTAL SITE ASSESSMENT

MESA TOPS  
RIDGEGATE PARKWAY AND INTERSTATE 25  
LONE TREE, COLORADO

Project No. DN52,036.000-200-R1R

September 26, 2023  
Revised October 7, 2025

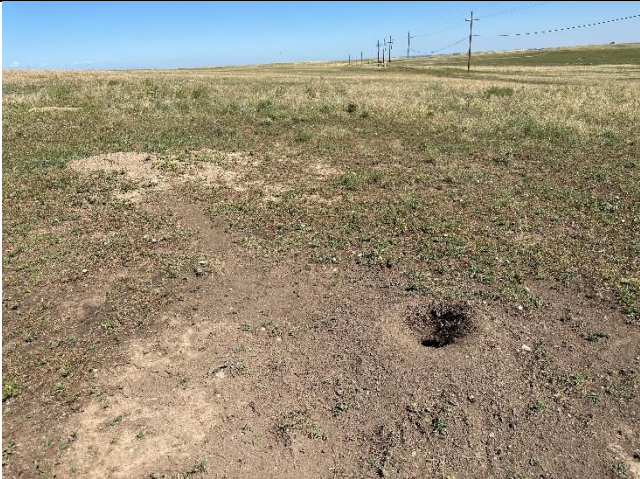
| Overall Property Photos | | | |
|---|--|---|--|
| Description: General View of Property and prairie dog burrow<br>Direction: North | | Description: General View of Property from center<br>Direction: East | |

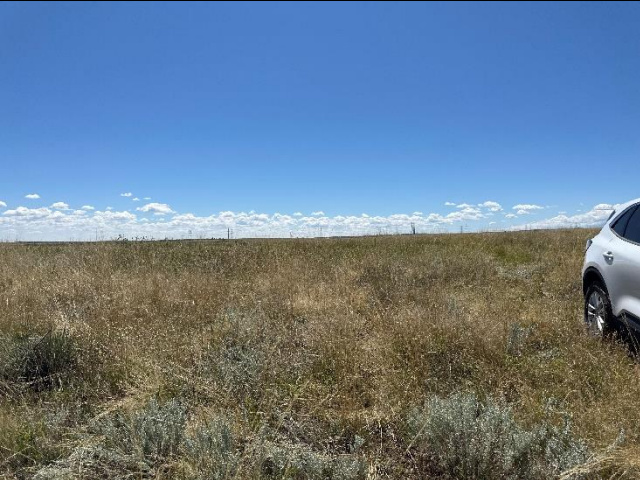
| Overall Property Photos | | | |
|---|--|---|--|
| Description: General View of Property from center<br>Direction: South | | Description: General View of Property from center<br>Direction: West | |

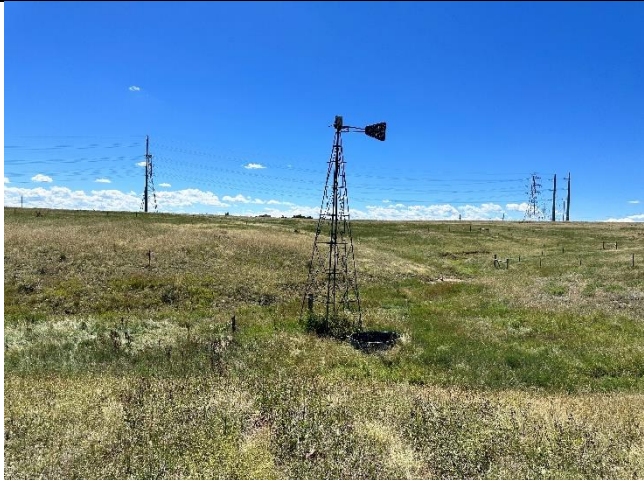
We observed one windmill-powered water well on the eastern portion of the Property. The well appeared to not be in use and was likely a remnant of agricultural and grazing activities. We do not consider the well to present a REC, but it should be properly abandoned prior to development.

| Overall Property Photos | |
|---|---|
| Description: Windmill-powered well near center/eastern portion<br>Direction: South | Description: Debris on eastern portion<br>Direction: West |

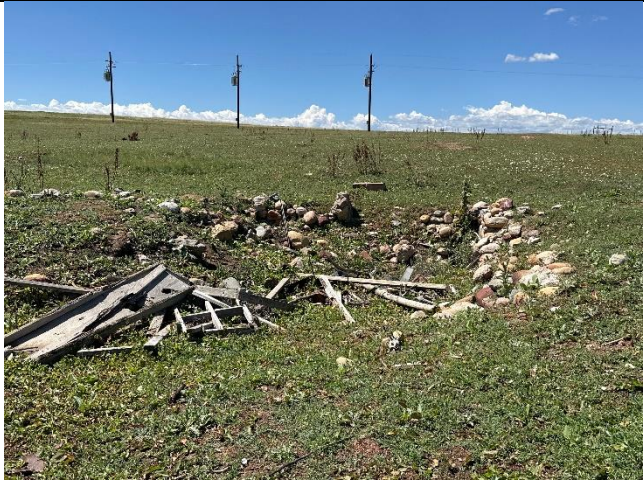
We observed a depression in the ground with cobbles at the base. In the depression there was a small amount of waste or debris. The exact origin is unknown. Based on our observations, we do not consider this finding to present a REC to the Subject Property.

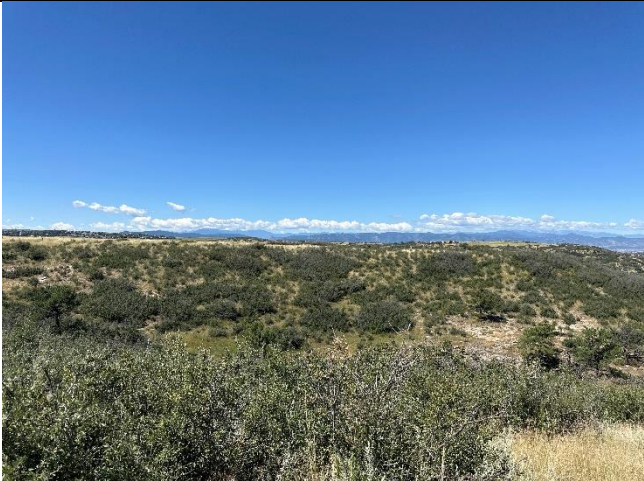
| Overall Property Photos | |
|---|---|
| Description: Drainage ditch on western portion<br>Direction: West | Description: High power transmission lines on and adjacent to Property<br>Direction: Northeast |

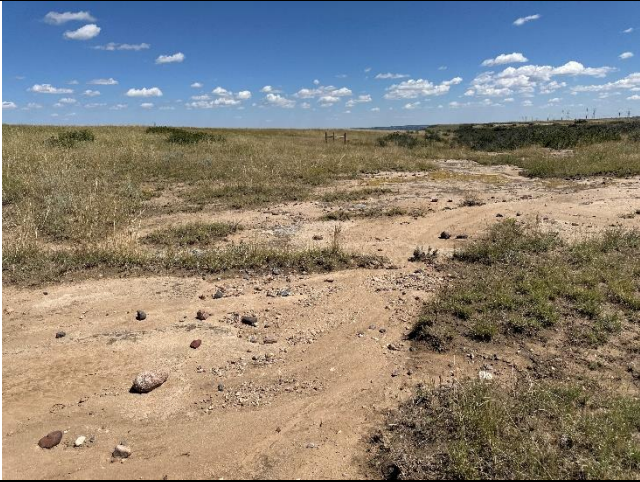
| Overall Property Photos | |
|---|---|
| Description: Bare soil near former agriculture plots<br>Direction: East | Description: Pole-mounted transformers<br>Direction: East |

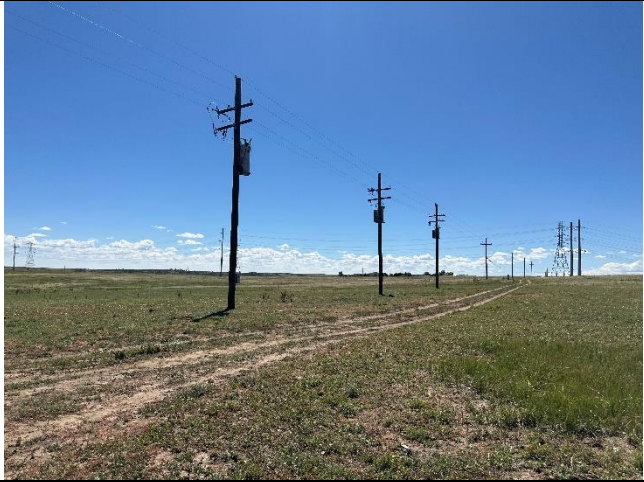
We observed at least three pole-mounted electrical transformers. We did not observe obvious staining or physical irregularities adjacent to the transformers. We do not believe this finding presents a REC to the Property.

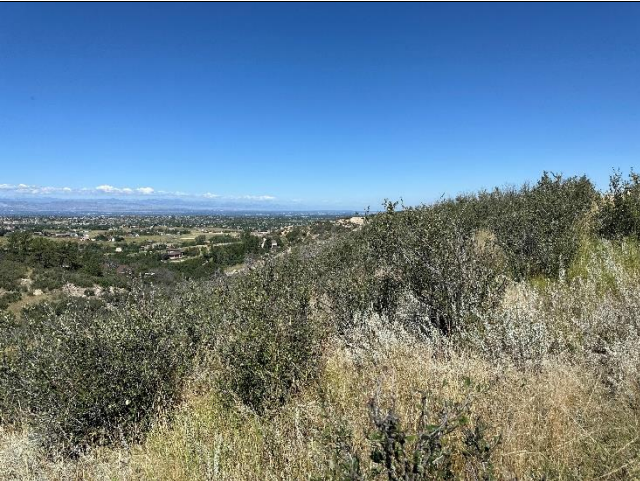
| Overall Property Photos | |
|---|---|
| Description: Drainage ditch on northern portion with residences beyond<br>Direction: North | Description: Interstate 25 and residences<br>Direction: Southeast |
