## REPORT

### Park Meadows Brick Wall Report

Park Meadows Brick Wall Study  
ANA Job No. 20-235  
September 3, 2021

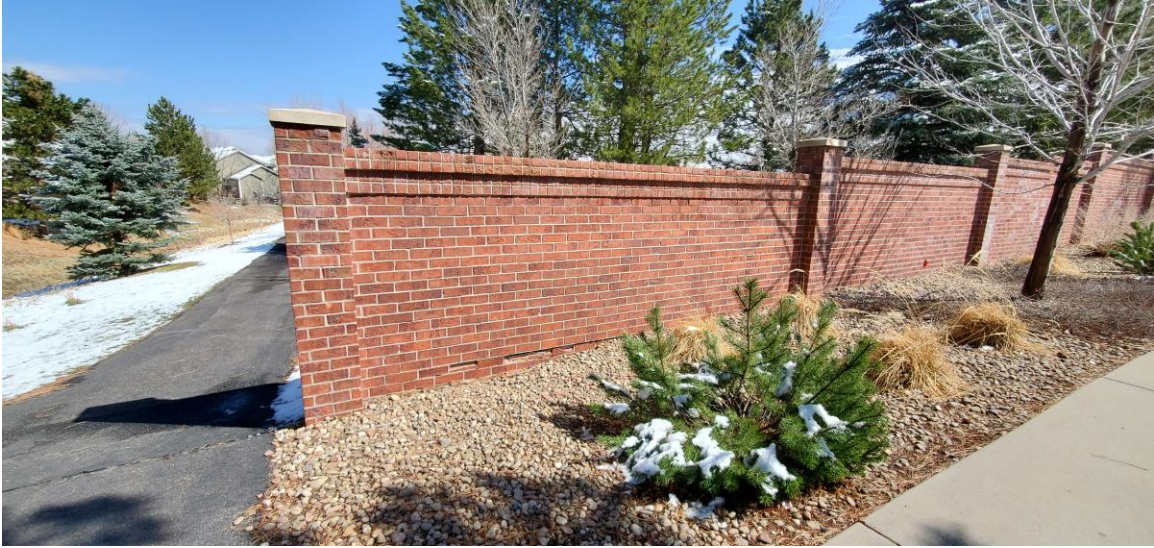
Figure 1. Overall view of typical brick wall panels.

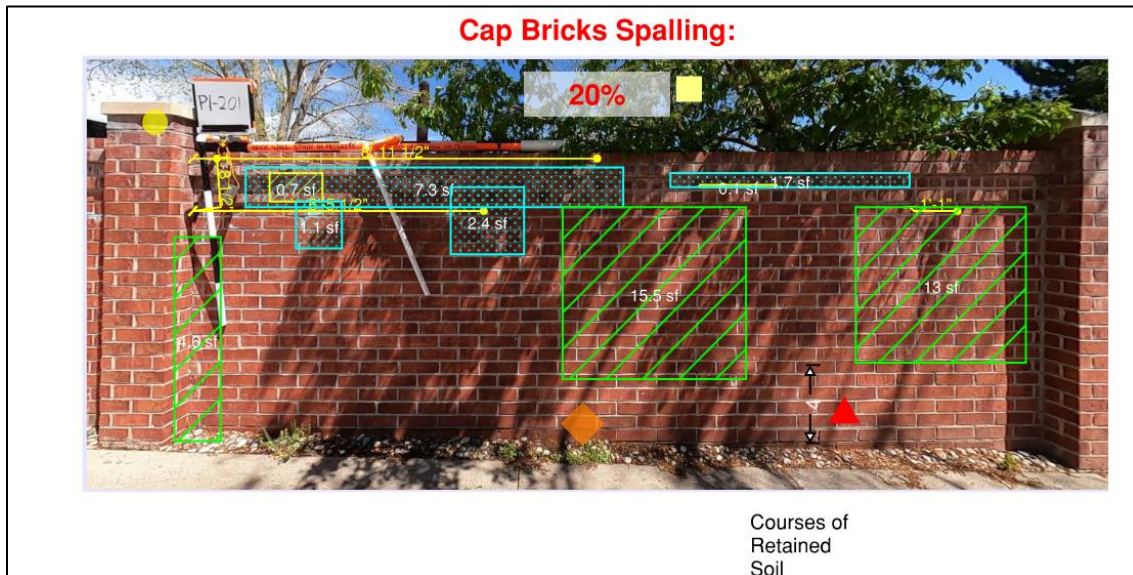
Figure 15. Example of distress mapping of a panel at P1-201.

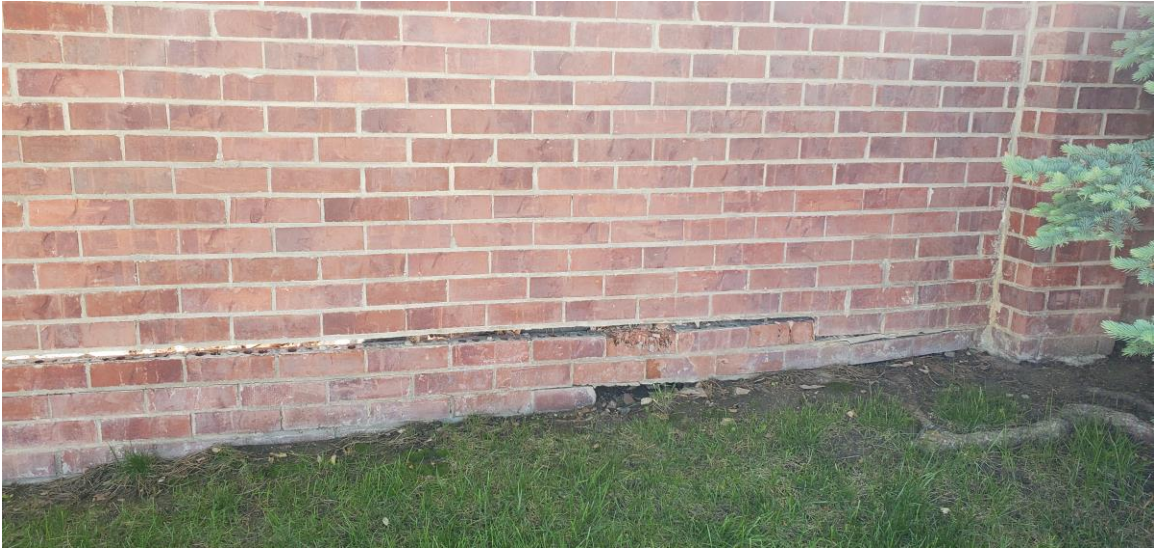
The type of distress referred to as panel sagging generally includes separation of the bottom few courses of brick downward from the remainder of a panel. The most common sagging behavior involves cracks or openings that are relatively wide at the middle and narrow at each end of a panel. However, sagging has also been observed near ends of panels and at steps along the bottom edge. ANA divided panel sagging into three different levels of distress: crack panel sagging, sag panel sagging, and collapse panel sagging (in order from minor to severe distress). Examples of each level of distress are shown in Figure 20 through Figure 22.

There are several likely contributing causes of panel sagging distress. One contributing factor is related to how loads travel through the panels. In structures, loads travel primarily along the stiffest available path. In the case of the wall panels, this path is often in an arch shape between the foundation supports. However, the original design envisioned that the panel would behave as a beam that spans over the gap between foundation supports. The arching action behavior places much of the top and ends of the panels in compression (which is beneficial in masonry), but the bottom center portion of the panels may be left to "hang" from this arch. This behavior is demonstrated schematically in Figure 23. Since only minimal smooth wire is oriented vertically to help resist this hanging motion, the bottom portion of the panel is prone to breaking free and sagging downward under its own weight.

A second contributing factor to panel sagging is the manner in which the bottom course "bond beam" is constructed. Since the width of the bottom course of brick is only approximately 2 5/8" thick, there is not room for a conventional bond beam unit with horizontal reinforcing that is grouted in place. Therefore, the construction consisted of reinforcing that was placed into a narrow slot with some mortar. Not only is the strength and bond of this mortared reinforcing substantially less than grouted reinforcing, but the mortar also provides very poor cover or corrosion protection for the reinforcing bars. For these reasons and others, installation of reinforcement with mortar is not permitted by the Building Code in these circumstances. One of the consequences of poor cover of the "bond beam" reinforcement is that many reinforcing bars have begun to corrode. Corrosion of steel involves expansion that is also contributing to popping the bottom courses of panels free from the supporting panel above.

Finally, another significant contributor to panel sagging is likely the very flexible nature of the panels. The body of the brick walls is only approximately 2 13/16 inches thick, significantly less than a standard brick thickness of 3 5/8". The flexibility of the panels is apparent from the vibration felt whenever a panel is knocked on with a fist or foot. This flexibility also makes the panels susceptible to damage from minor impacts such as lawn mowers or shovels striking along the bottom edge.

Figure 22. Example of "Collapse Panel Sagging" distress, the severe category of panel sagging.

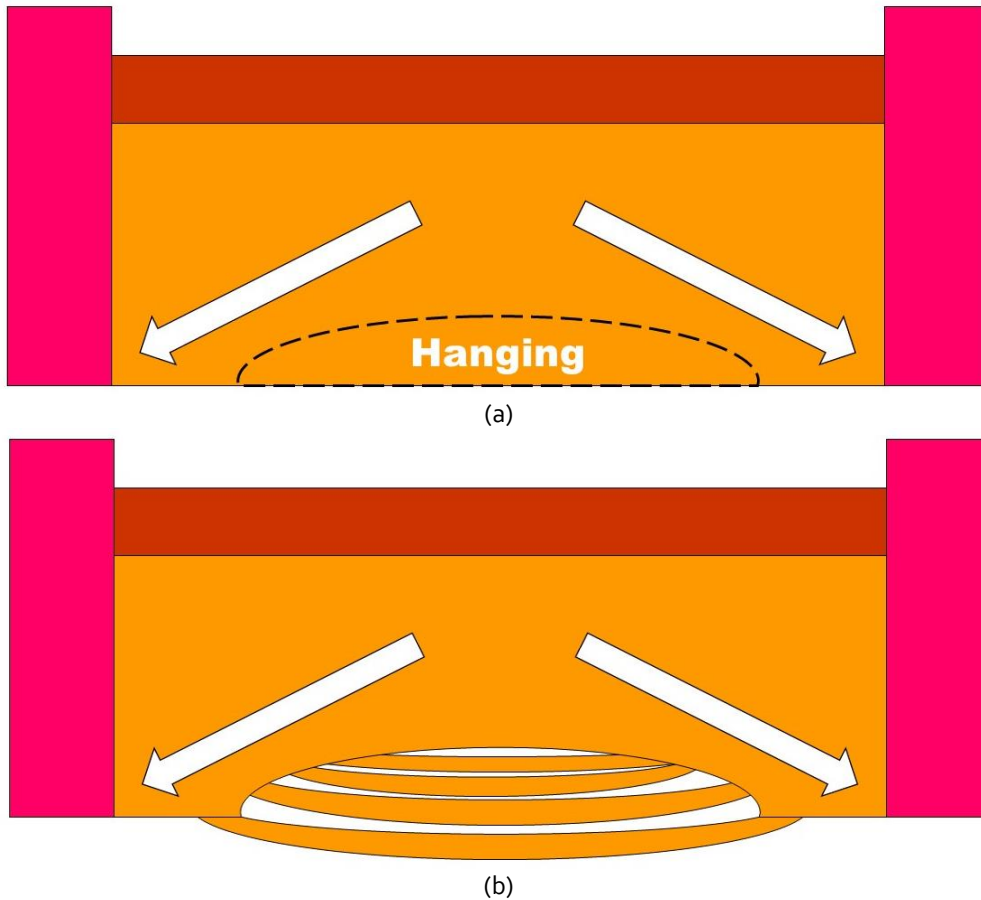
Figure 23. Schematic diagram of arching action of panel between foundation supports that contributes to panel sagging (a) showing the load arching diagonally to the foundation supports with the middle bottom portion of the

panel "hanging" from the arch above (b) showing failure and sagging of the bottom middle portion of the panels. Movements are exaggerated for clarity.

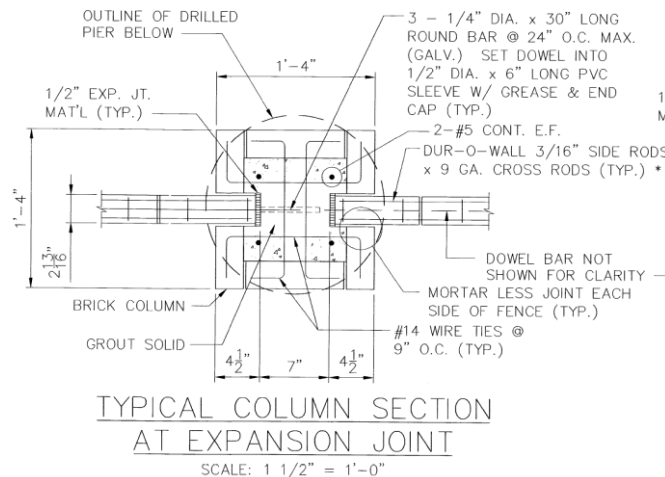
There are several common construction issues related to expansion joint installation at the subject walls. The most common issue is that the open joint required between the cap and column at the expansion joint location is often filled with mortar or is constructed without any gap. Where this condition is present, the brick panels expand, and the body of the panels is permitted to slide into the slotted expansion joint within the column. However, the cap pushes on the column and has no room to expand. Since this pushing is generally happening from both sides, the caps tend to crack horizontally and buckle upward, sometimes bringing the top of the column along with them, as shown schematically in Figure 25. Examples of the column pop-up behavior are shown in Figure 26 and Figure 27.

Figure 24. Detail from original design drawings showing the design of expansion joints on both sides of a column.

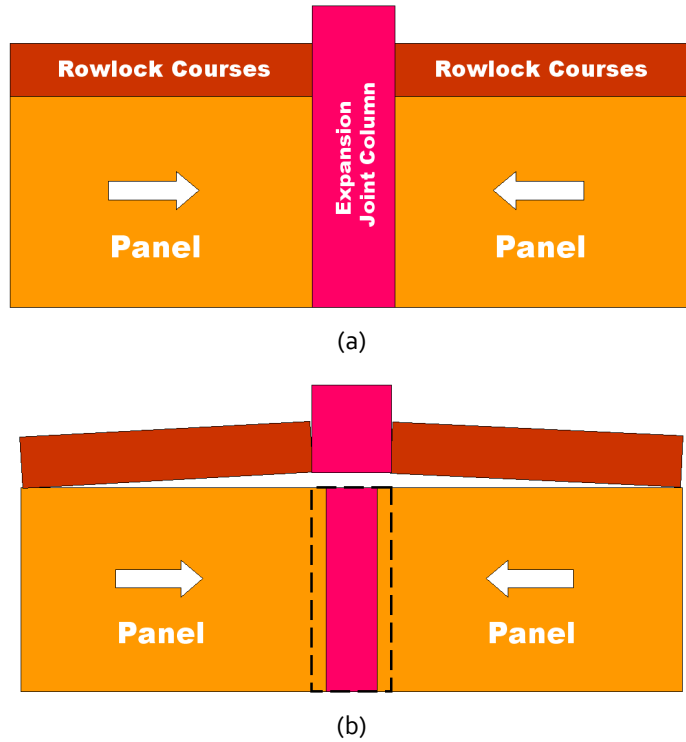
Since the root cause of this distress is solid expansion joints in wall caps, the solid expansion joint itself was documented as a distress condition ("Cap Solid Expansion Joint"). The horizontal cracking and buckling of the caps may also occur without lifting the tops of columns, and this distress was traced as "Cracking", and will be discussed in a subsequent section. Additionally, the slotted expansion joints along the height of the panel (beneath the caps) are intended to be free of mortar, as shown in the design detail, to permit free expansion of the panels. This joint was sometimes mortared solid, and this condition was documented as "Panel Solid Expansion Joint".

Figure 25. Schematic diagrams of panel behavior at expansion joints with top portion full of mortar leading to column pop-up (a) the original configuration and direction of panel expansion and (b) the displaced configuration if the expansion joints at the base of panels are effective and the rowlock courses cannot accommodate movement. Movement is exaggerated for clarity.

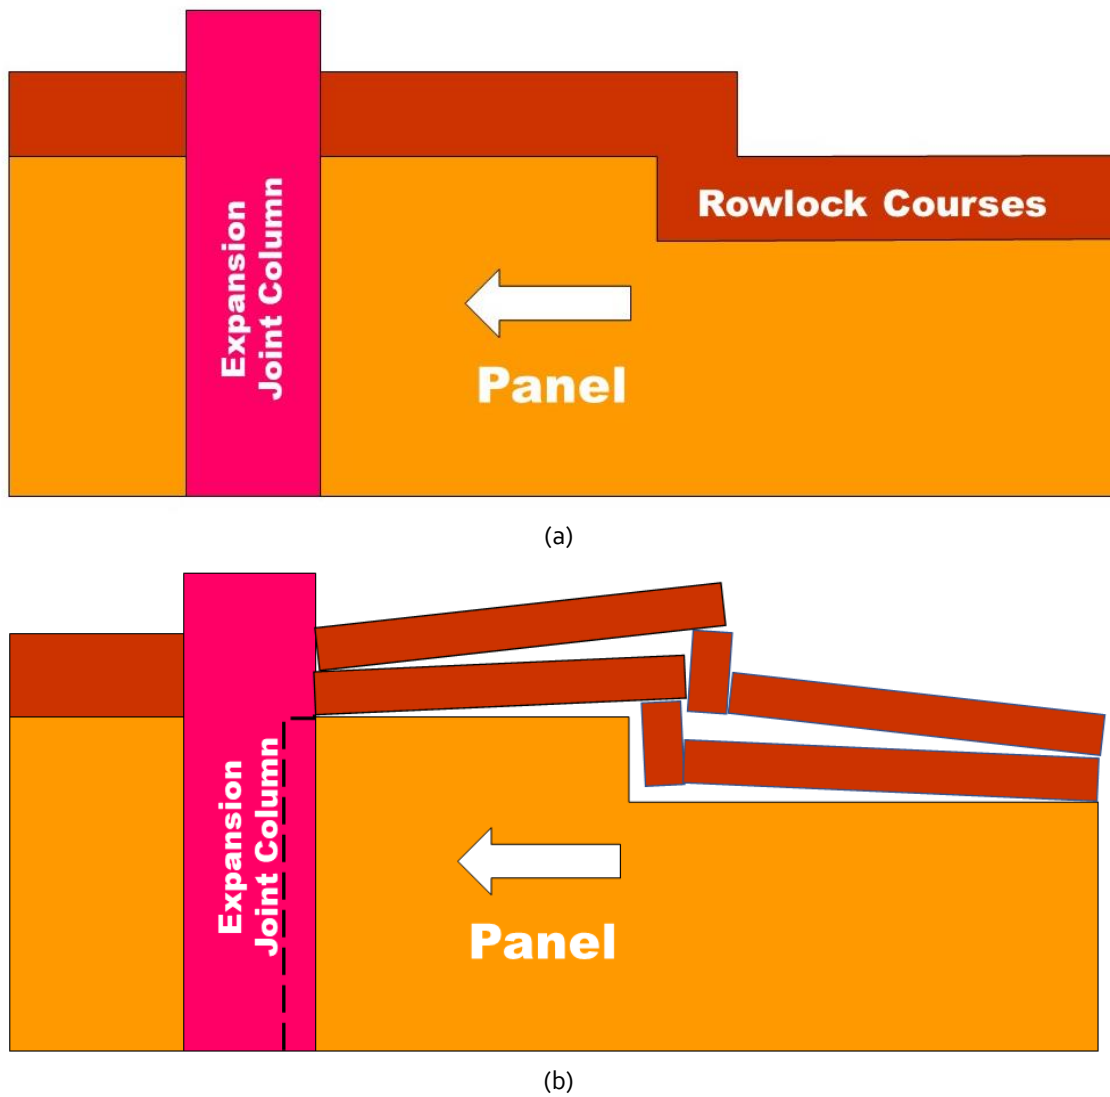
As discussed in the section above related to Column Pop-Up, caps with solid expansion joints tended to cause buckling of the caps as the brick expands. This behavior can lead to extensive horizontal cracking, generally concentrated in or near the caps. This cracking is sometimes exacerbated by a step-down in the cap at panels where the ground slopes along the length of the wall, as shown schematically in Figure 31. An example of cracking in a panel is shown in Figure 32.

Figure 31. Schematic diagrams of panel behavior at expansion joints with top portion full of mortar leading to horizontal cracks (a) the original configuration and direction of panel expansion and (b) the displaced configuration if the expansion joints at the base of panels are effective and the rowlock courses cannot accommodate movement. Movement is exaggerated for clarity.

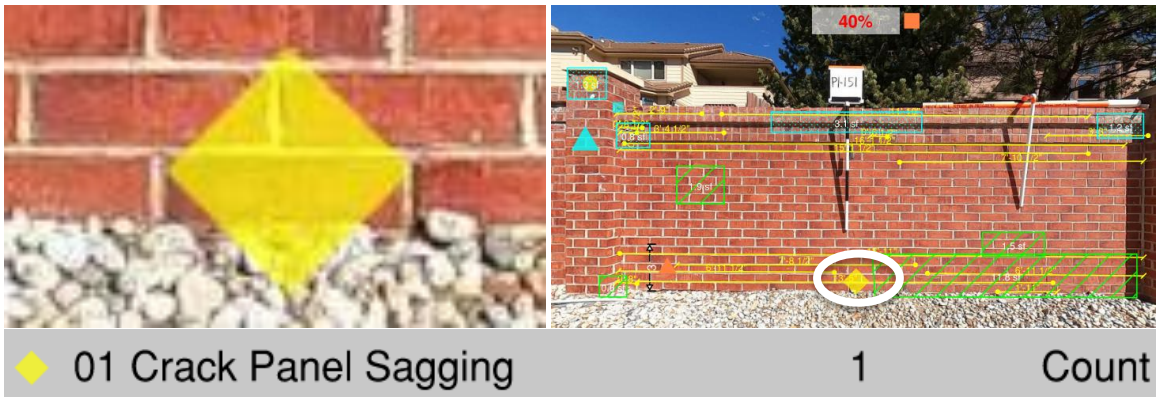
Figure 44. A diamond of yellow color indicates cracked panel sagging, which is the lowest of the three levels of sagging (minor). There are also orange and red diamonds. Orange represents sag panel sagging (moderate) and red represents collapse panel sagging (severe). These symbols are usually found toward the bottom of panel where the sagging is located on the panel. The cracks are marked as a Crack type of distress for minor sagging only since repointing moderate or severe cracking without reconstruction is not practical. In the legend, sagging is measured as a count, indicating that there is a certain type of sag or crack on the bottom of the panel (either one or zero sagging marks per panel).

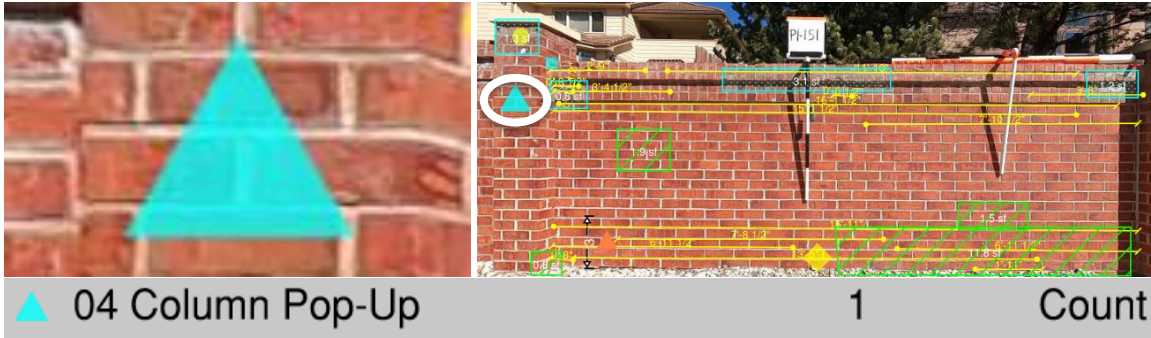
Figure 45. A large blue triangle represents a column pop-up. This indicates that at the top of the column there is either a large crack going through the entire column, or the column top is visibly separated from the rest of the column. The triangle will be found on the left side column toward the top of the column. In the legend it will show up as a one count for each panel that has this type of distress.

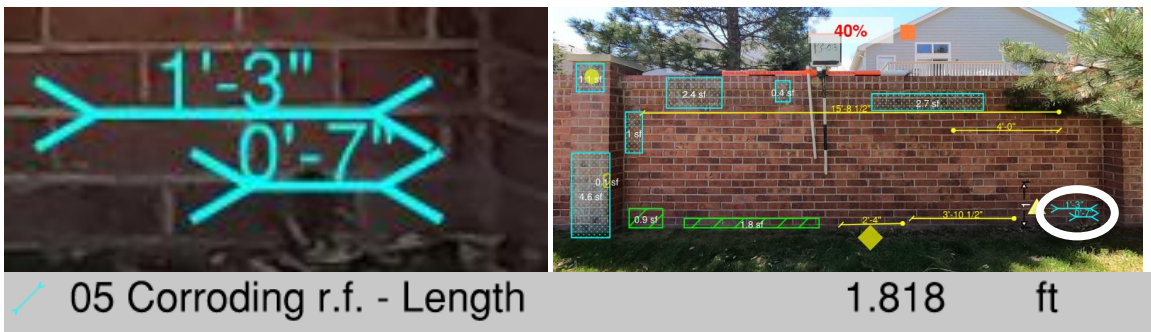
Figure 46. The blue lines represent corroding reinforcement within the panel. There is both bed joint reinforcing at each course of brick in the panels studied and a bond beam at the base of the panel. Corrosion can be found anywhere on the wall but is often in the lower courses. In the picture, the corroding reinforcements shows up as a linear measurement of feet and inches. The length showed in the legend will be the sum of all of the lengths of corroding reinforcing for the panel.

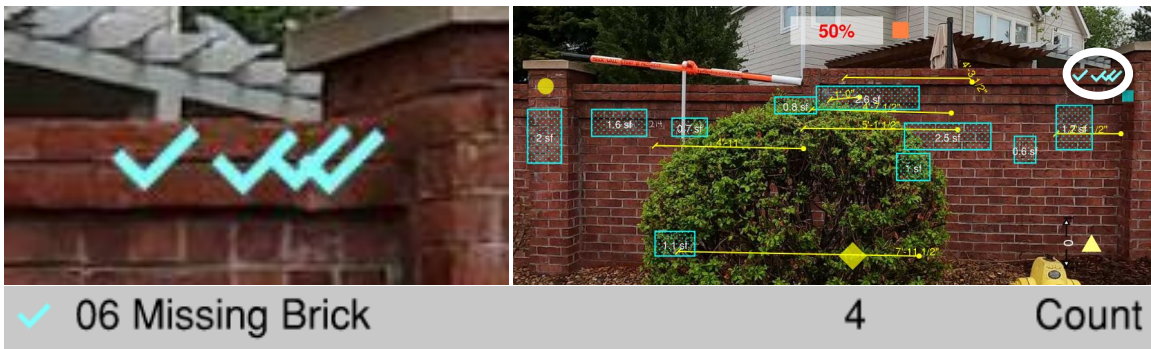
Figure 47. Missing bricks are indicated by blue checkmarks at the location where the units are missing on a panel. These can be found anywhere on the panel, but in most cases, missing units were observed on the top of the panel (within the cap) or at the very bottom of the panel. Units that were eroded to the point of significant material loss were also marked as "missing" since they would require replacement as a repair. Each checkmark is considered one count, which is shown in the legend. In this case there are four checkmarks and, therefore, four missing bricks.

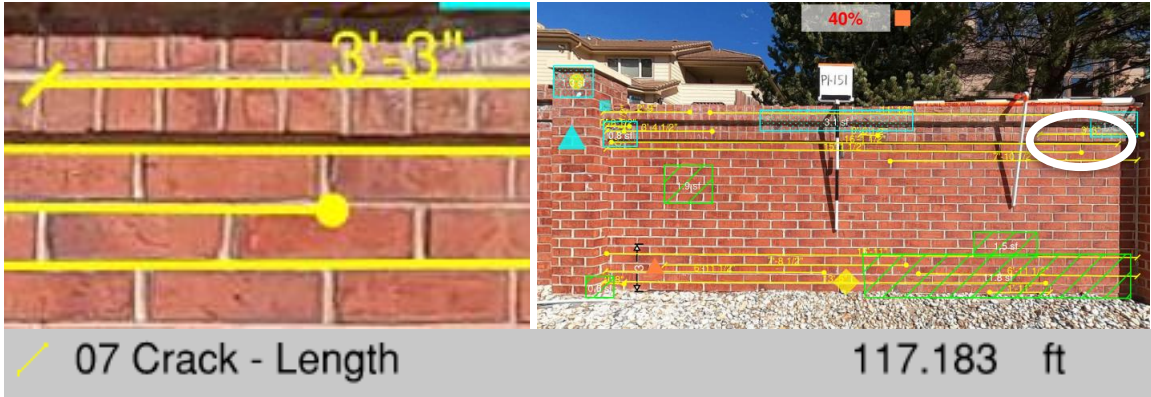
Figure 48. Crack length is indicated with a yellow line that represents vertical or horizontal cracking on the panel. Cracking can be found anywhere on the panel and was marked on the bottom where crack panel sagging has been identified. Horizontal cracking near the top of the panel was the most commonly observed location. Horizontal cracking in general was much more common than vertical cracking. In the legend, this distress is displayed as a length in feet with sum of the total length of cracking on the panel.

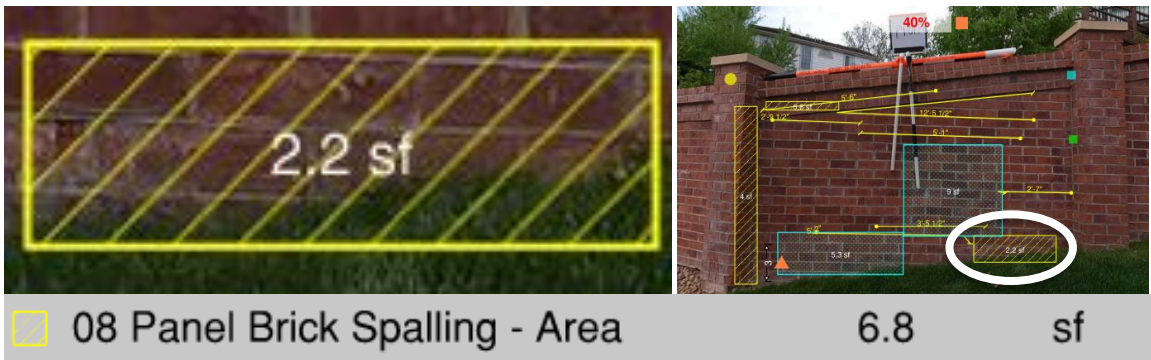
Figure 49. Panel spalling is represented by a yellow rectangle with a diagonal hatch. This distress can be found anywhere on the panel, but it is most commonly found toward the bottom of the panel, as shown in the picture above. The unit of measurement is square feet of area. In the legend, the total area in square feet of all the panel spalling areas added together is displayed.

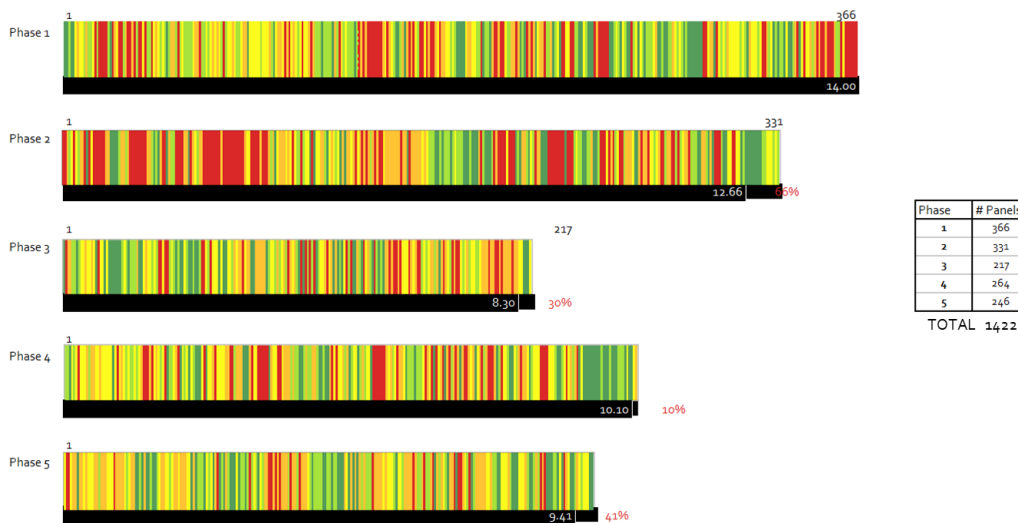
When each panel is displayed as a narrow bar of color corresponding to its grade, it is possible to detect patterns of areas of relatively good conditions (concentrated green or white areas) and relatively poor conditions (concentrated red or black areas), as shown in Figure 58. Since the panel numbers are sequential based on location, these groups will also generally be in close proximity to one another.

Figure 58. Heat maps of each phase indicating areas of concentrated panels in relatively good condition (green) and relatively poor condition (red).

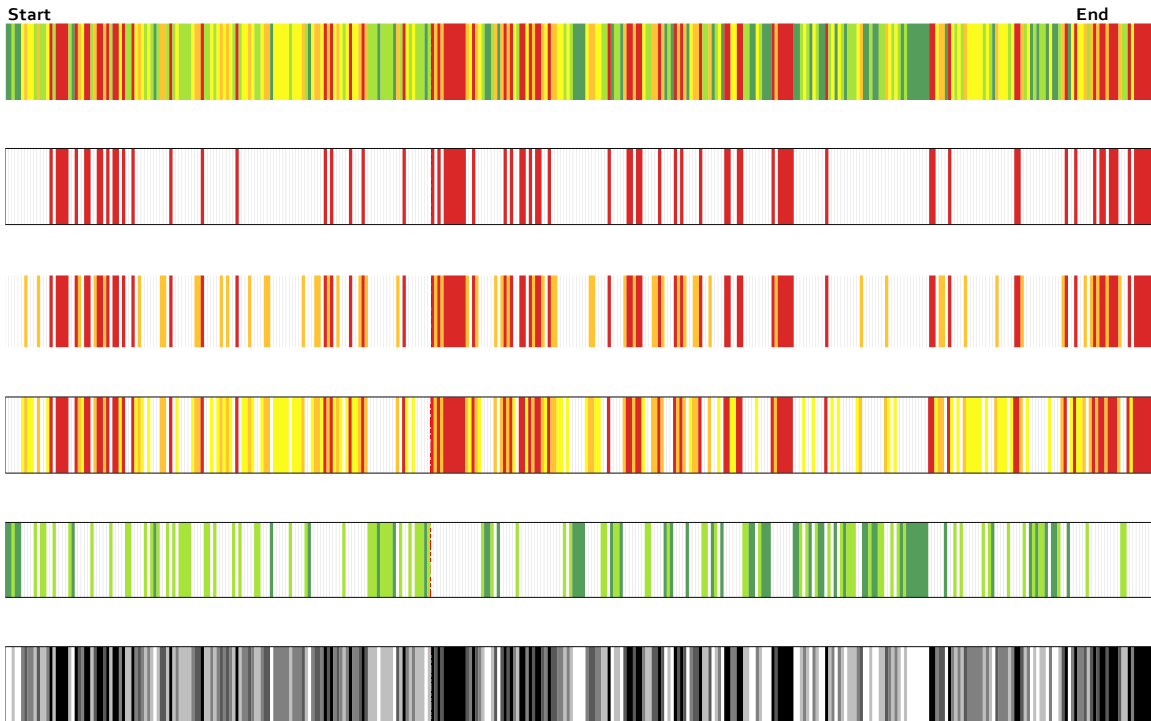
Figure 59. Phase 1 heat maps with all grades included in the top and bottom images and only selected grades in the others.

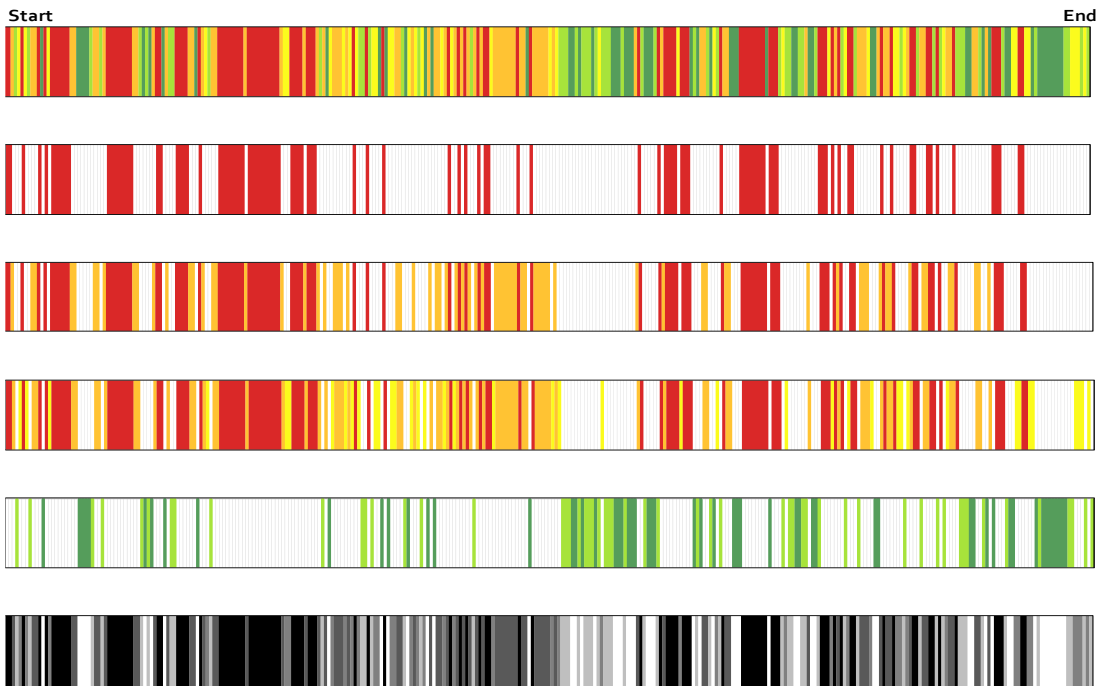
Figure 60. Phase 2 heat maps with all grades included in the top and bottom images and only selected grades in the others.

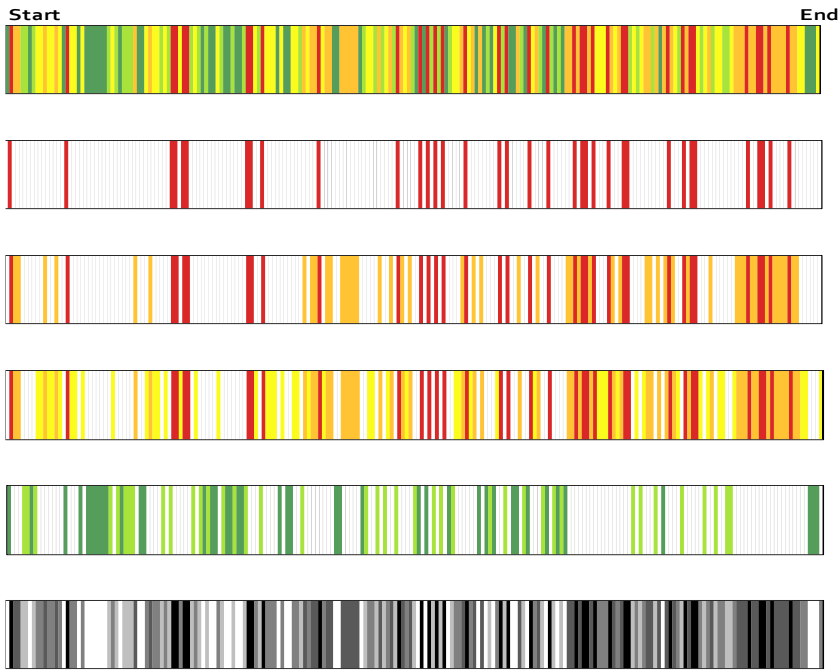
Figure 61. Phase 3 heat maps with all grades included in the top and bottom images and only selected grades in the others.

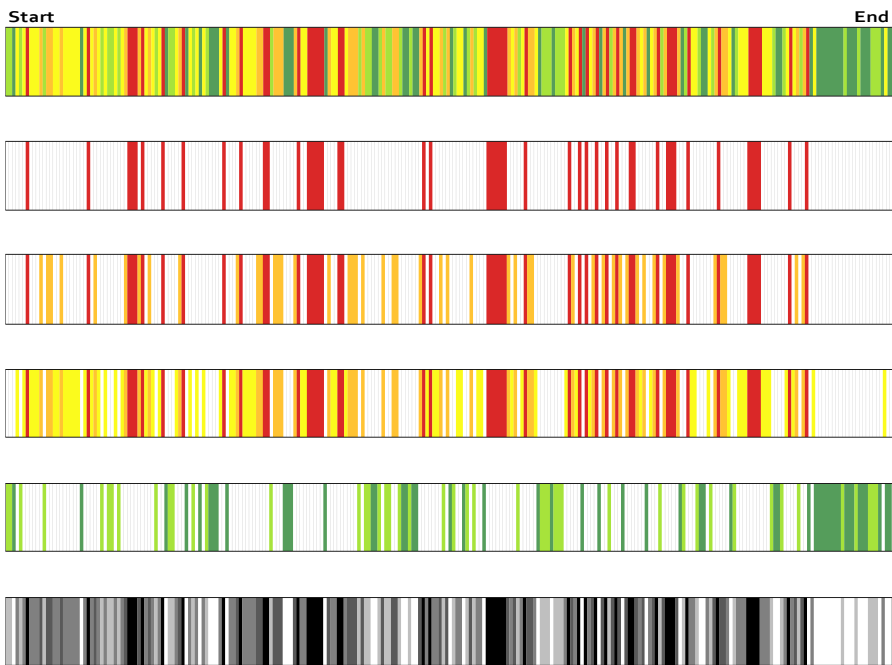
Figure 62. Phase 4 heat maps with all grades included in the top and bottom images and only selected grades in the others.

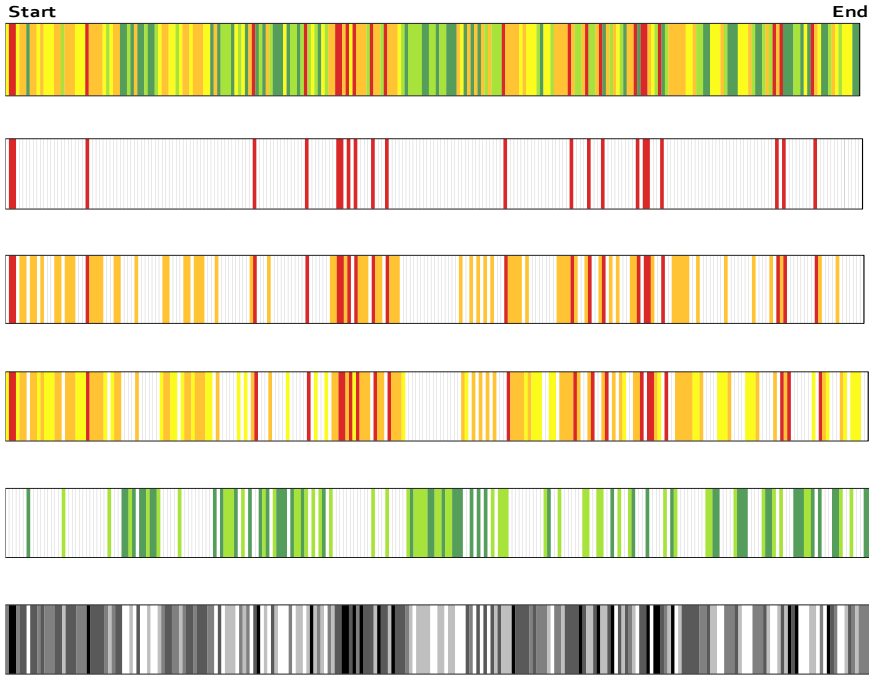
Figure 63. Phase 5 heat maps with all grades included in the top and bottom images and only selected grades in the others.

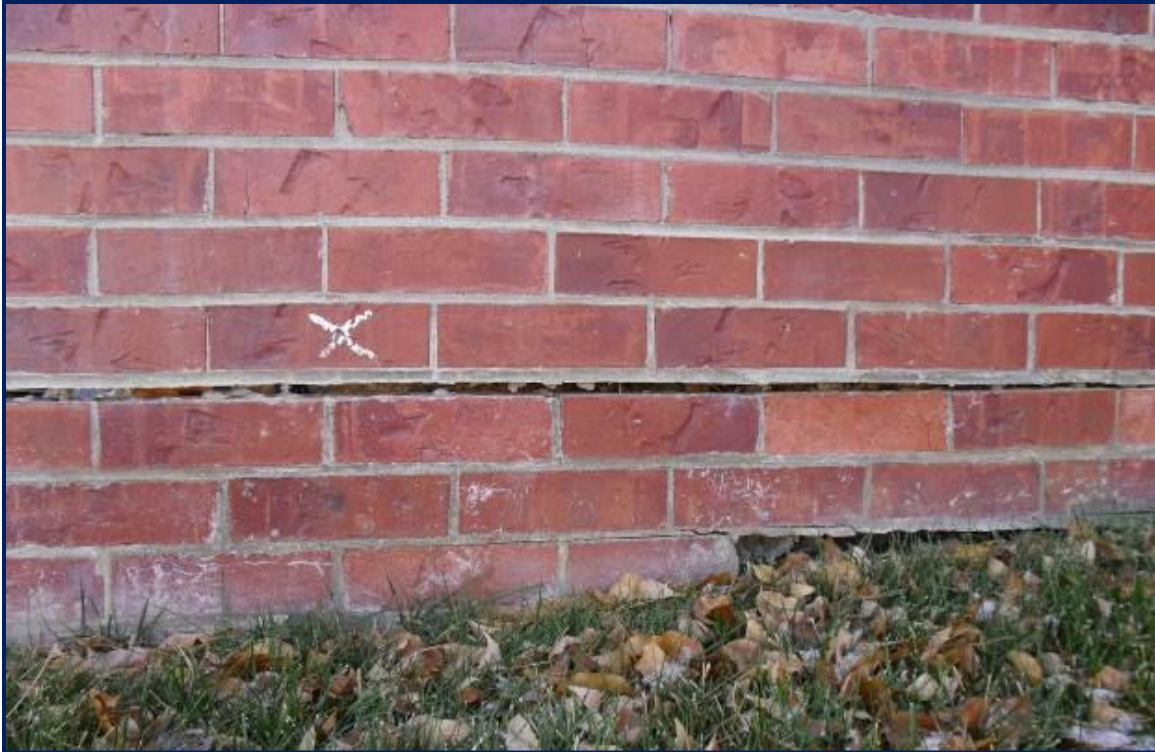
For example, Table 5 includes a summary of the sagging panels observed in 2011 and in 2021. The total percentage of panels with observed sagging in 2011 was 43%, and it was 67% in 2021. It is important to note that the 2011 survey did not provide any indication of the severity of sag at each panel. However, in comparing photographs from 2011 and 2021 from the same panels, it is clear that sagging distress has become more severe over the past 10 years. An example is shown in Figure 67 and Figure 68.

Figure 67. Sagging at P1-323 as photographed in 2011.

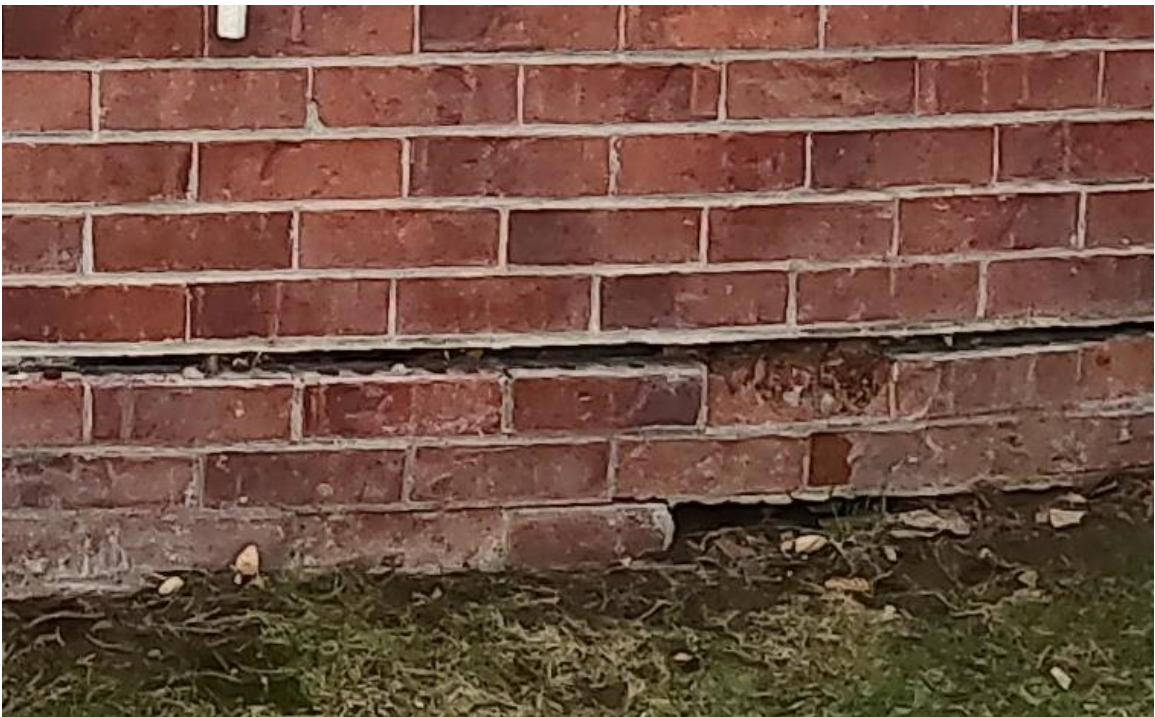
Figure 68. Sagging P1-323 as photographed in 2021.

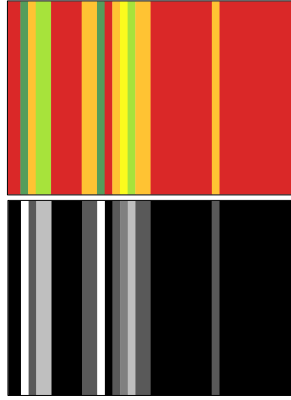
Since areas of significant distress will tend to deteriorate more quickly than brick walls that are in relatively good condition, it is logical to focus repair and/or replacement campaigns in areas of significant damage first. However, jumping between individual panels that are spread apart is not an efficient use of materials and mobilization. Therefore, finding groups of panels in poor condition is one reasonable means of prioritizing repairs. The heat map and GIS tools can be used to find these groups of distress in order to prioritize repair efforts. An example of how this could be done is provided below. A portion of the Phase 2 heat map is shown in Figure 71 from Section C, Panels P2-047 through P2-081. The location of these panels is provided in Figure 72, and a summary of the grades is provided in Table 7. This area has a high concentration of panels in the bottom 20<sup>th</sup> percentile. Since the panels are grouped together, it would be relatively efficient to repair or replace multiple panels in the same area in a single mobilization.

Figure 71. Portion of Phase 2 Heat Map in color (top) and black and white (bottom) in an area of concentrated poor conditions.

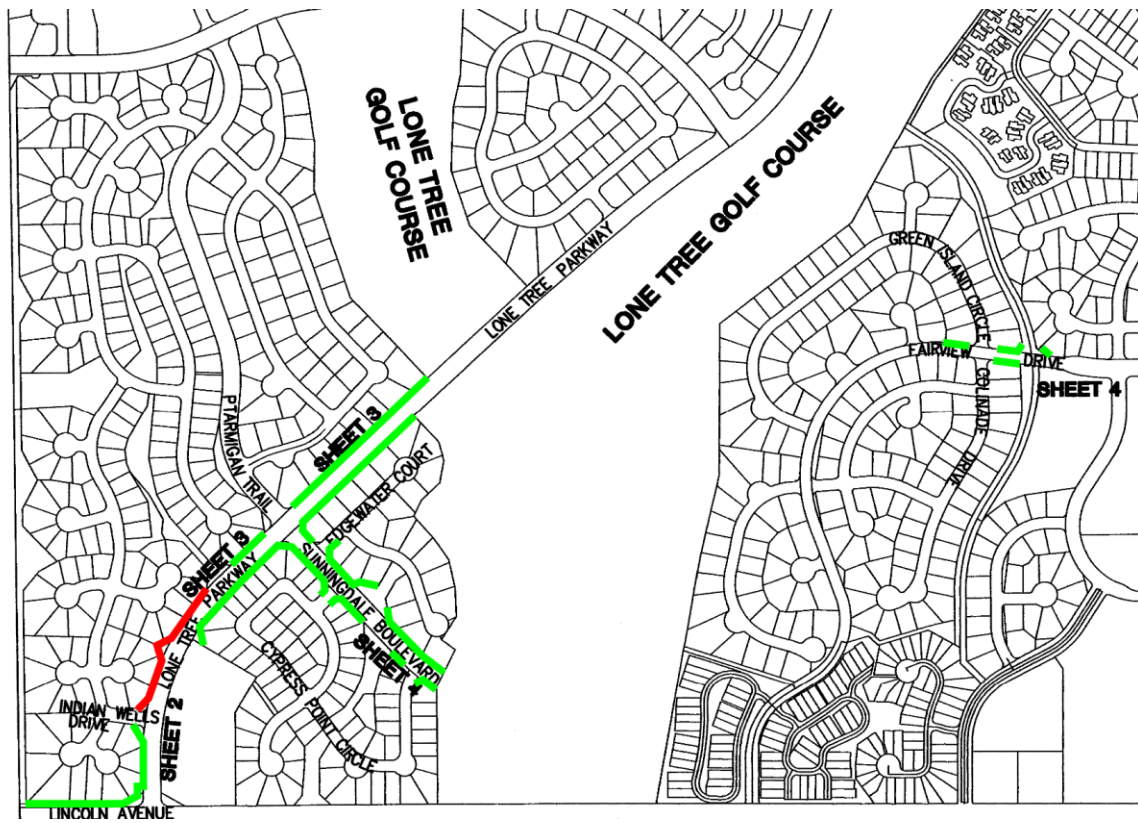
Figure 72. Location shown in red of the area represented by the Heat Map in Figure 71.
