Subject: Updated Preliminary Geotechnical Investigation and  
Slope Stability Evaluation  
Ridgegate – Mesa Tops Road Alignment  
Douglas County, Colorado  
Project No. DN52,378-125-L2

CTL|Thompson performed a Preliminary Geotechnical Investigation for the proposed road alignment for Cabela Drive within the Ridgegate – Mesa Tops development in Lone Tree, Colorado (Project No. DN52,378.000-115-R1; report dated March 12, 2025). We have been requested to review proposed grading plans and perform slope stability evaluation for the proposed road alignment. The purpose of our evaluation was to assess slope stability for the existing slopes relative to planned cuts and fills for the Mesa Tops Road Alignment. This letter is based on our understanding of the planned development, previous investigations, and our experience. The discussions and criteria presented in this letter are intended for planning purposes only. This letter has been revised to address review comments.

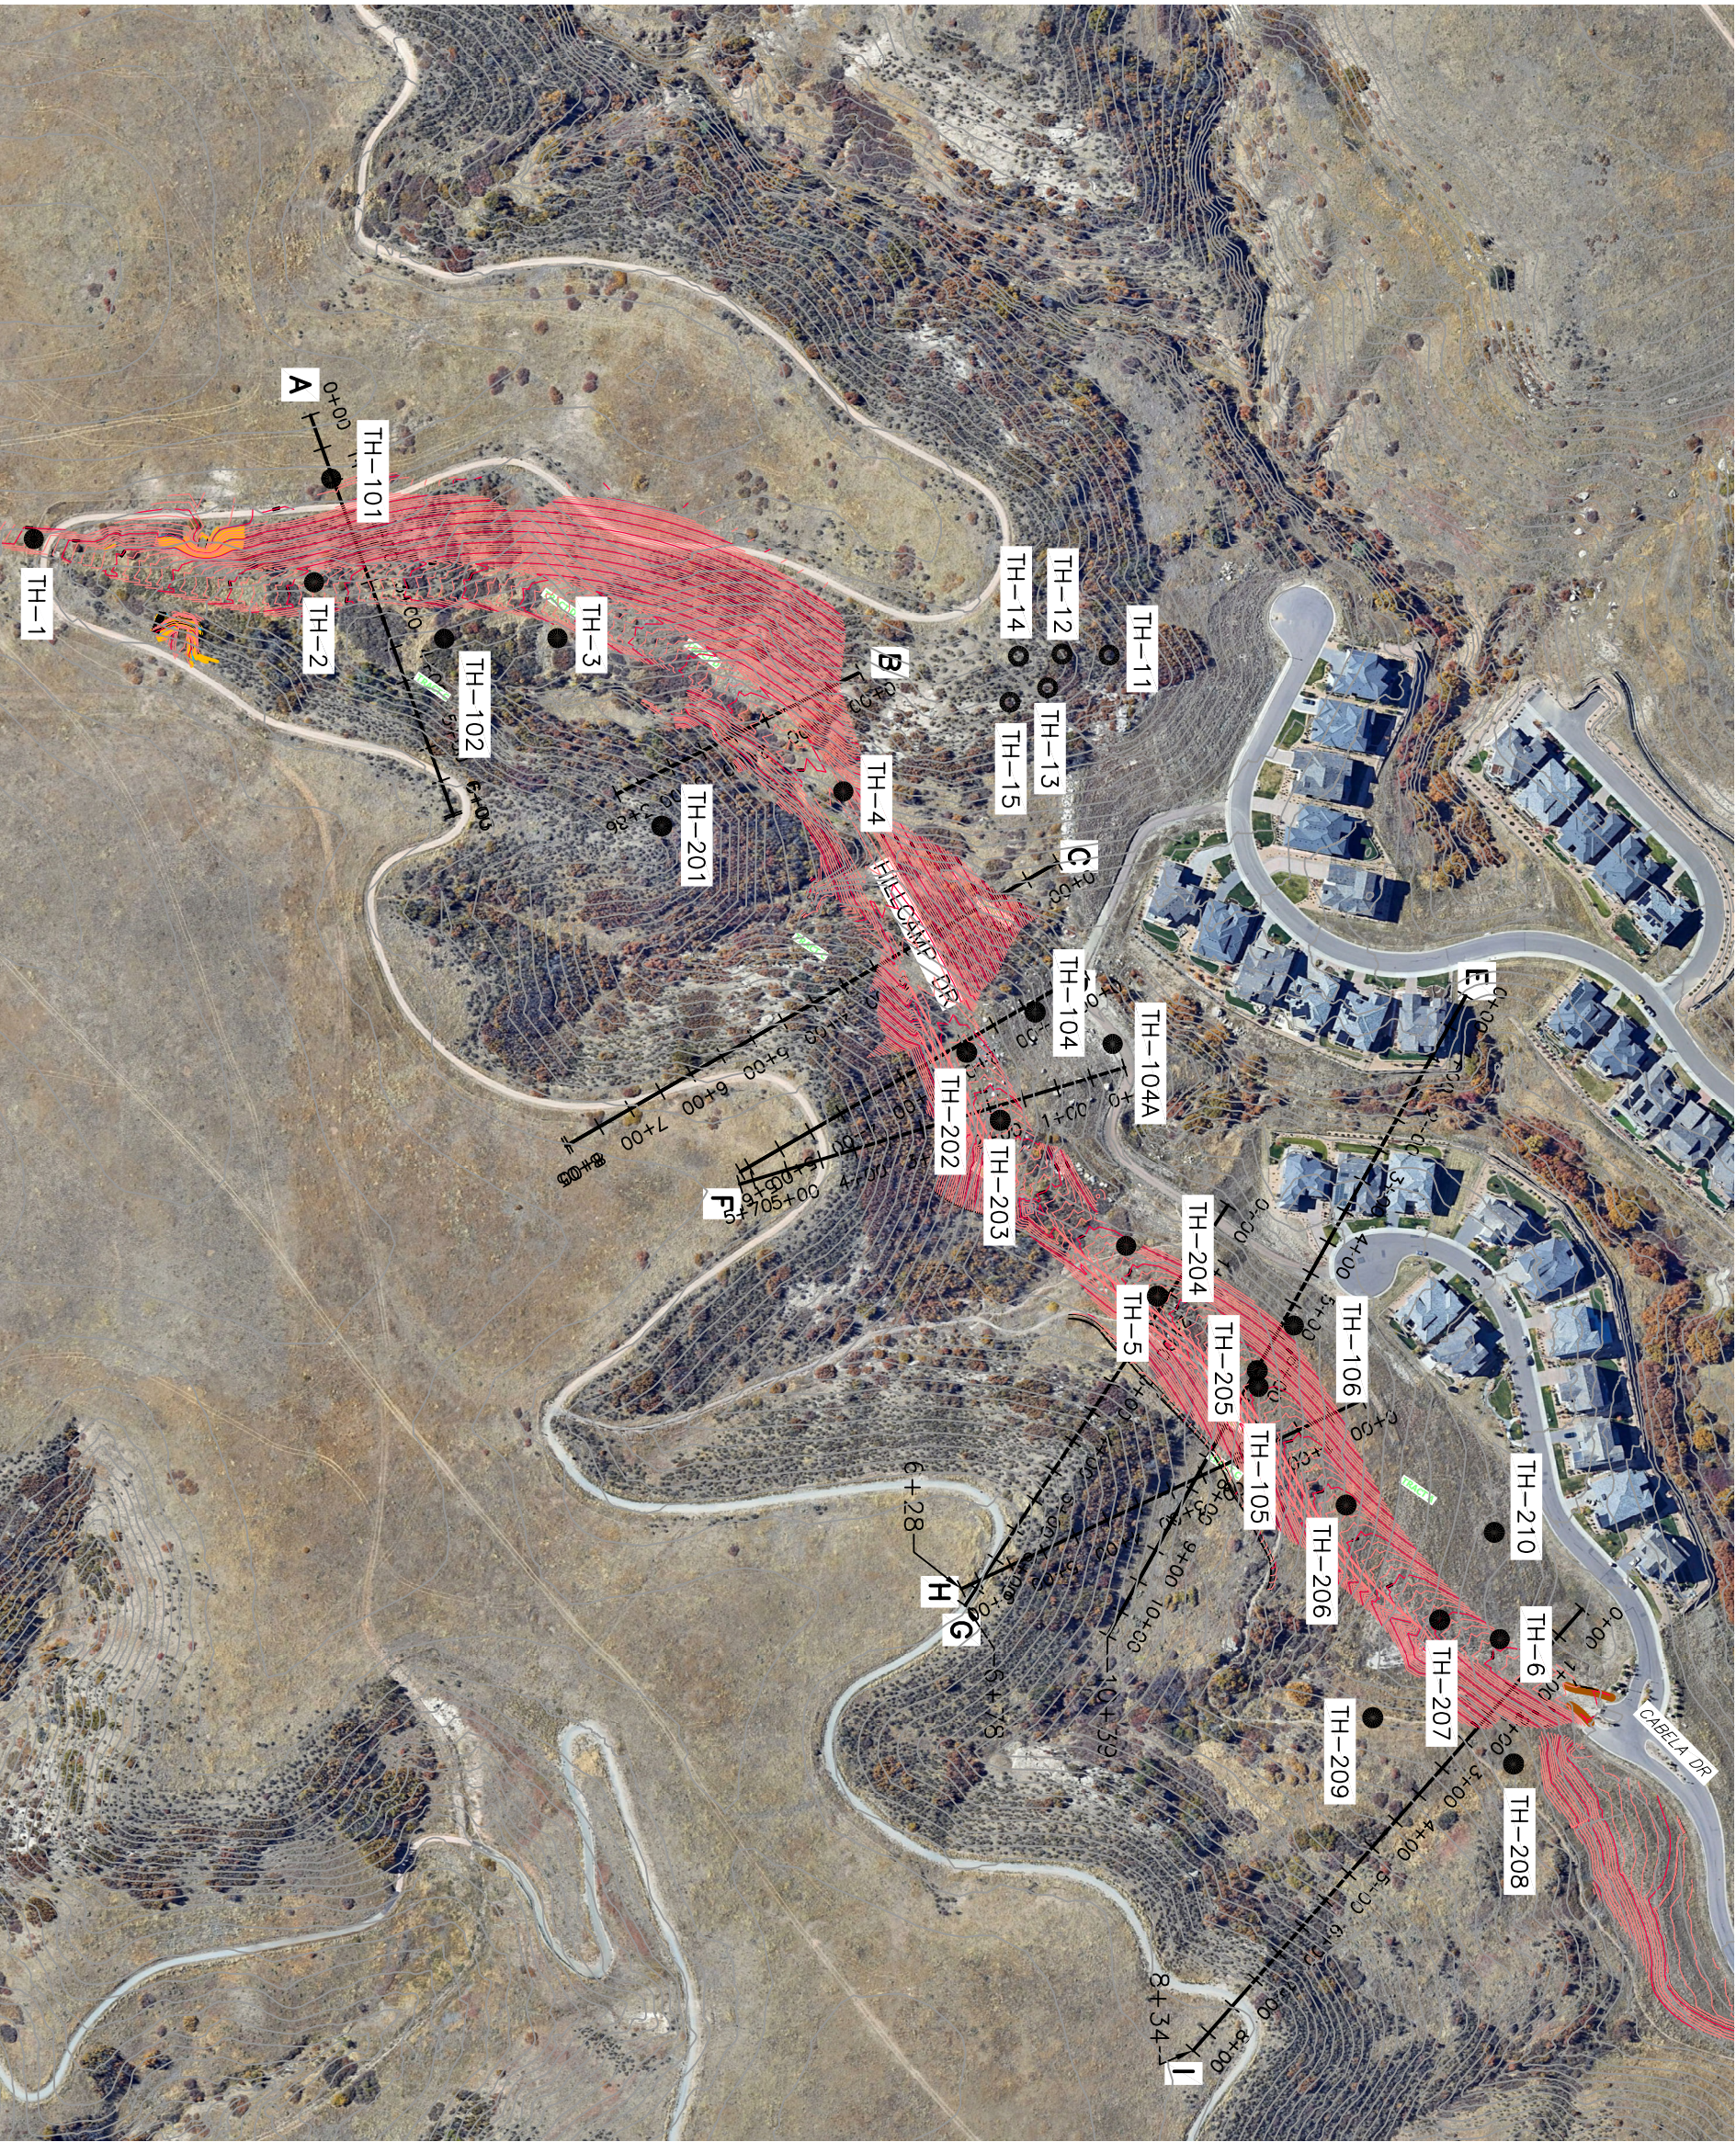
Locations of  
Exploratory  
Borings

We investigated subsurface conditions on September 11 and 12, 2024 and between February 13 and 26, 2026 by drilling 22 widely-spaced exploratory borings at the approximate locations shown on Figs. 1A and 1B. Sixteen slope stability borings (TH-101 to TH-106 and TH-201 to TH-210) were drilled along slope areas in conjunction with six pavement borings (TH-1 to TH-6) drilled along the proposed road segment. We were unable to drill two of the proposed slope stability borings (TH-103) on the central portion of the site due to access issues and an additional boring (TH-104A) was drilled near the bottom of the proposed slope. Boring TH-104A is located about 150 feet northeast of the proposed location of TH-104; due to the presence of utilities on the north side of the slope and steep conditions on the south side of the slope, this was the most accessible location for drilling. An alternative location for TH-103 was not selected due to an external waterline laid upon the ground surface preventing access to the slopes south and east of the fire access road where the original boring was proposed. There were no viable access points or alternative locations that would allow access to the slope near TH-103. Drill rig refusal was encountered in one boring (TH-101) at a depth of about 11 feet below existing grade. Boring locations and elevations were staked and surveyed by others. Some borings were moved due to access issues and the approximate locations and elevations were determined by a representative of our firm using a Leica GPS unit referencing the North American Datum of 1983 (NAD83).

Nine slope cross-sections were considered, as shown on Figs. 1A and 1B. We were provided the Overall Grading Plan from the Hillcamp Trail Civil Construction Plans dated March 13, 2026. Our analysis and recommendations are based on construction as currently planned. Slope stability should be reevaluated if revisions are made to the planned construction.
